STAR ONLINE PUBLICATION

Case Number: S2323000079

Symptom/Vehicle Issue: Scraping sound from steering column

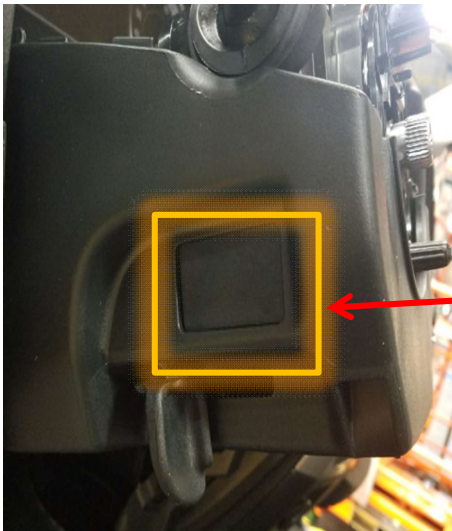
Diagnosis: Rubbing noise is heard while turning the steering wheel, from the upper steering column shroud area.

Repair Procedure: Inspect the column shroud near the SCCM (steering column control module) for contact. If found, remove the upper and lower column shrouds, and reset using the following procedure:

Install the Lower Shroud First.
