## UPDATE FROM WARRANTY OPERATIONS

## Catalyst Failure Can Cause an Engine Failure – All Models and Model Years

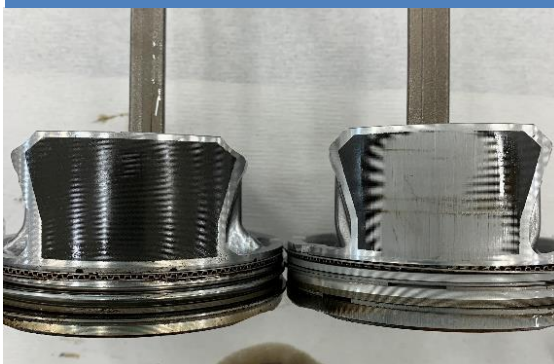
Piston skirts become scored from catalyst debris.

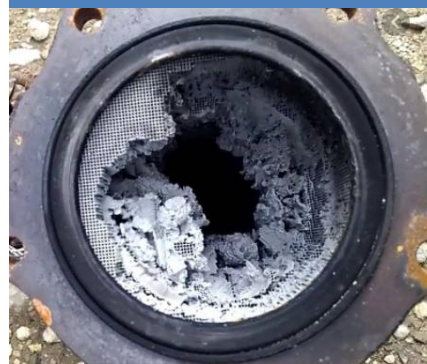
Eroded and broken Catalyst

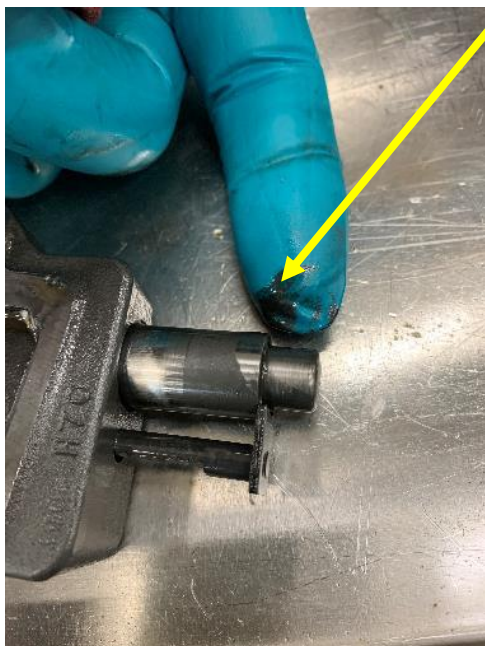
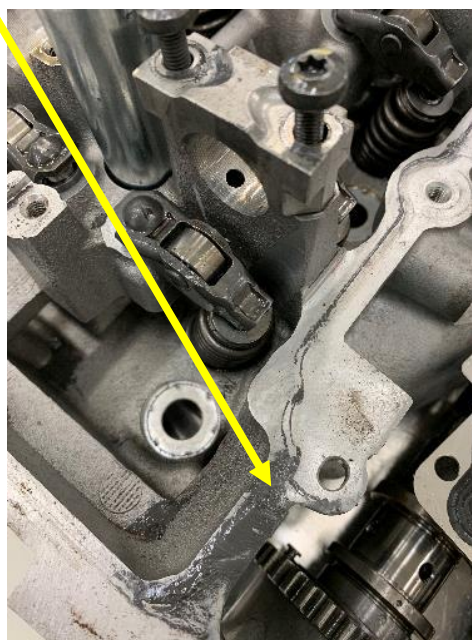
Internal engine components will have a grey oily appearance most identified under the rocker cover area or timing chain area
