REFERENCE:	TSB: 23-098-23 REV. A GROUP: 23 - Body	Date:	October 4, 2023	REVISION:	23-098-23
VEHICLES AFFECTED:	2019 - 2021 (DT) RAM 1500 Pickup This bulletin applies to vehicles built on and before September 30, 2020 (MDH 0930XX) equipped with a Rear Power Sliding Window (Sales Code GFE) or Rear Sliding Window (Sales Code GFD).			MARKET APPLICABILITY: <input checked="" type="checkbox"/> NA <input type="checkbox"/> MEA <input type="checkbox"/> SA <input type="checkbox"/> IAP <input type="checkbox"/> EE <input type="checkbox"/> CH	
CUSTOMER SYMPTOM:	The customer may experience one or more of the following: <ul style="list-style-type: none"> • A cracked backlite frame Fig. 1 resulting in an interior water leak (crack is visible to the customer). • Water leak from at top of the backlite. 				
CAUSE:	Manufacturing issue.

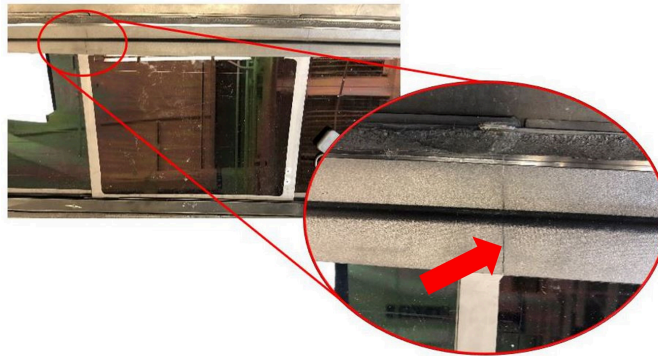
Fig. 1
Cracked Backlite Frame (Left Side Shown, Crack Can Also Be On The Right Side)

NOTE: Before performing this Repair Procedure, quickly visually inspect the backlite frame for a crack [Fig. 1](#) at the top corners of the sliding backlite window.

This bulletin involves replacing the backlite.

1. Replace the backlite. Refer to the detailed service procedures listed in DealerConnect>Service Library under: 23 - Body / Stationary Glass / Backlite / Removal and Installation.
