REFERENCE:	TSB: 23-104-23 GROUP: 23 - Body	Date:	October 7, 2023	REVISION:	-
VEHICLES AFFECTED:	2015 - 2018 (BU) Jeep Renegade 2019 - 2023 (BV) Jeep Renegade This bulletin applies to BV vehicles built on or before October 28, 2022 (MDH 1028XX).	MARKET APPLICABILITY:			
CUSTOMER SYMPTOM:	One or both front door side window seals are deformed Fig. 1 .				
CAUSE:	Manufacturing issue.

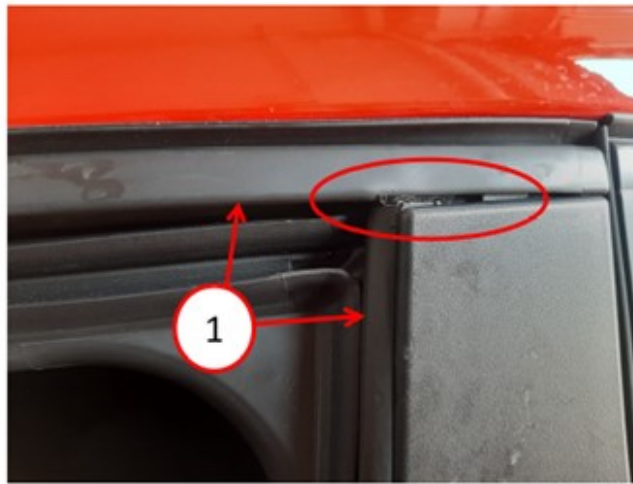
Fig. 1
Deformed Front Door Window Seal

1 -One Piece Window Seal (Glass Run) To Inspect And Replace (If Required)

NOTE: Do not just replace the door window seal (glass run) for this Repair Procedure. The door glass MUST also be replaced to complete repair.

1. Replace the front side door glass and door glass seals (glass runs) as required. Refer to the detailed service procedures available in DealerCONNECT> Service Library under: Service Info>23 - Body / Doors - Front / Glass, Door / Removal and Installation.
