REFERENCE:	TSB: 09-019-23 GROUP: 09 - Engine	Date:	October 7, 2023	REVISION:	-
VEHICLES AFFECTED:	2019 – 2022 (DS) RAM 1500 Pickup 2019 – 2022 (DS) RAM Truck (Mexico) 2019 – 2022 (WD) Dodge Durango 2019 – 2021 (WK) Jeep Grand Cherokee 2021 – 2022 (WL) Jeep Grand Cherokee This bulletin applies to vehicles built with the 5.7L V8 Hemi MDS VVT engine (Sales Codes EZH) or the 5.7L V8 Hemi VVT engine (Sales Code EZC).			MARKET APPLICABILITY:	
				<input checked="" type="checkbox"/> NA	<input type="checkbox"/> MEA
				<input type="checkbox"/> SA	<input type="checkbox"/> IAP
				<input type="checkbox"/> EE	<input type="checkbox"/> CH
CUSTOMER SYMPTOM:	The customer may describe an ticking noise from the exhaust manifold location(s) when cold.				
CAUSE:	Updated exhaust manifold kit.

This bulletin involves replacing the exhaust manifolds.

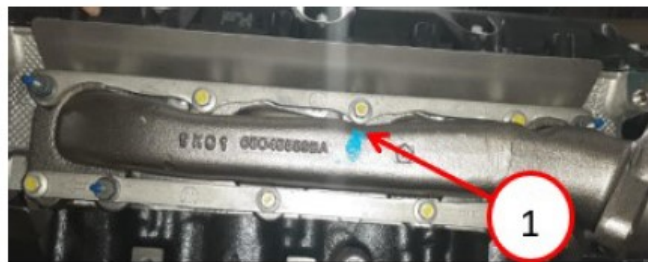
Fig. 1
Exhaust Manifold Crack Area

1. Start the vehicle cold. Listen for ticking noise that stops after engine is warmed up.
2. Shut engine off and allow engine to cool.
3. Remove exhaust manifold heat shield(s) from the side that is suspect to be leaking for manifold inspection.
4. Re-start cold engine and listen for noise source at exhaust manifold area.
5. Visually inspect for a cracked manifold and confirm it is not a casting parting line or casting fin in location Fig. 1.

1 - Manifold Crack Area
