REFERENCE:	TSB: 08-229-23 GROUP: 08 - Electrical	Date:	October 12, 2023	REVISION:	–
VEHICLES AFFECTED:	2019 - 2023 (BV) Jeep Renegade 2020 - 2021 (M7) Jeep Compass 2020 - 2022 (M6) Jeep Compass 2021 - 2023 (MV) Jeep Compass This bulletin applies to vehicles equipped with a Global Telematics Box Module (Sales Code RDG) and Connectivity - Europe (Sales Code (RTK)). This bulletin applies to: <ul style="list-style-type: none"> • MV vehicles built on and before January 16, 2023 (MDH 0116XX). • BV vehicles built on and before January 23, 2023 (MDH 0123XX). 			MARKET APPLICABILITY: <input checked="" type="checkbox"/> NA <input type="checkbox"/> MEA <input type="checkbox"/> SA <input type="checkbox"/> IAP <input checked="" type="checkbox"/> EE <input type="checkbox"/> CH	
CUSTOMER SYMPTOM:	The customer may experience the one or more of the following: <ul style="list-style-type: none"> • Outdated vehicle data on customer's mobile app. • Connected Services maintenance popup displayed on the radio screen. • Connected Services battery maintenance popup displayed on the radio screen.

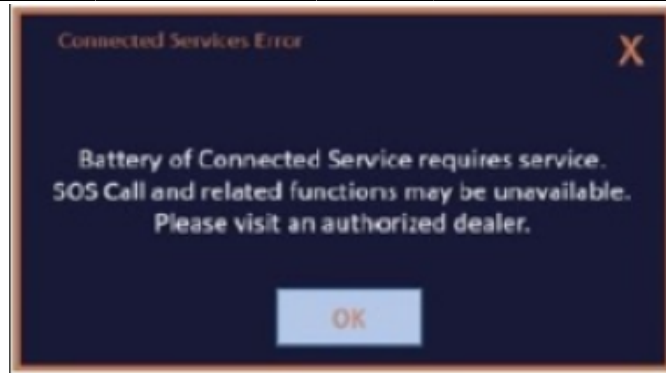
CAUSE:	TBM Software

Fig. 1
Battery Of Connected Services Requires Service

Messages displayed on the radio screen: “Battery of Connected Services Requires Service.” , “Battery of Connected Services is Temporarily Low” and “Connected Services requires service” Fig. 1 , Fig. 2 and Fig. 3.

This bulletin involves reprogramming the Global Telematics Box Module with the latest available software.

1. Reprogram the TBM with the latest software. Detailed instructions for flashing control modules using the wiTECH Diagnostic Application are available by selecting the application’s “HELP” tab.
2. Clear all DTCs that may have been set in any module due to reprogramming. The wiTECH application will automatically present all DTCs after the flash and allow them to be cleared.

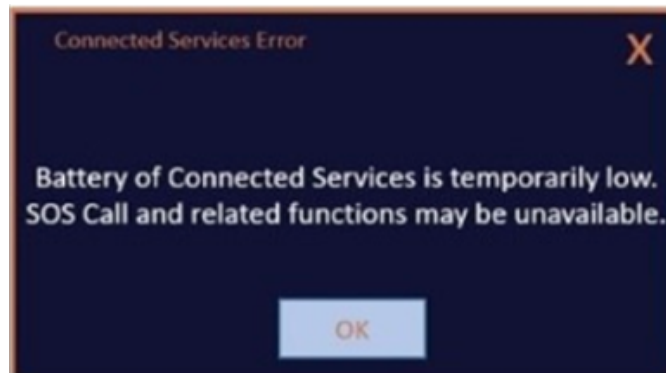
Fig. 2
Battery Of Connected Services Is Low

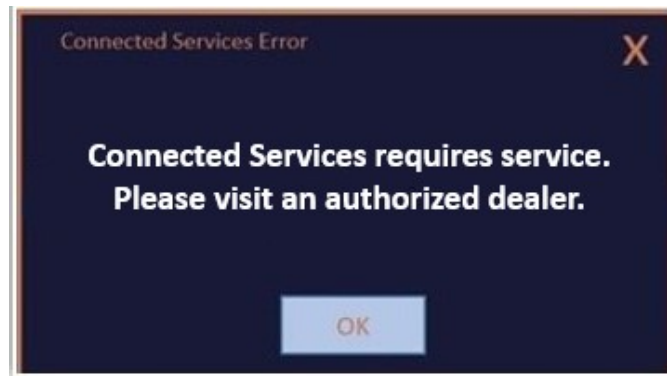
Fig. 3
Connected Services Message
