STELLANTIS PARTS & SERVICES		Technical Service Bulletin (TSB) Seat Belt Height Adjuster		
REFERENCE:	TSB: 10-002-23 GROUP: 10 - Restraints	Date:	October 27, 2023	REVISION: -
VEHICLES AFFECTED:	2023 (M7) Jeep Compass This bulletin applies to vehicles built on or after August 23, 2023 (MDH 0823XX) and on or before September 21, 2023 (MDH 0921XX).			MARKET APPLICABILITY: <input type="checkbox"/> NA <input checked="" type="checkbox"/> MEA <input type="checkbox"/> SA <input type="checkbox"/> IAP <input checked="" type="checkbox"/> EE <input type="checkbox"/> CH
CUSTOMER SYMPTOM:	Customers may experience the seat belt position adjuster will not adjust to the maximum height position.			
CAUSE:	Incorrectly installed upper B-Pillar trim panel retaining clip.

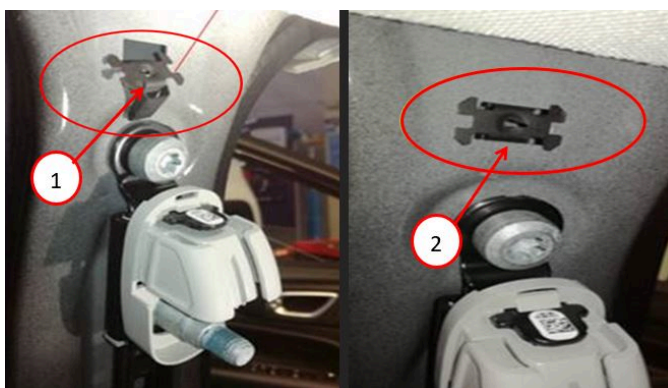
Fig. 1
B-Pillar Clip

1 - Improperly Installed B-Pillar Clip
2 - Properly Installed B-Pillar Clip

1. Inspect the seat belt height adjuster on both the front driver and passenger side for the proper adjustment range.
2. Does the seat belt height adjuster exhibit full range when adjusting on both the front driver and passenger side?
 - YES>>>> This bulletin has been completed. Use Inspection LOP (23-19-21-90) to close the active RSU.
 - NO>>>> Proceed to [Step 3](#).
3. Replace the affected upper B-Pillar trim panel. Refer to the detailed service procedure listed in DealerCONNECT> Service Library under: 23 - Body / Interior / Panel, B-Pillar Trim, Upper / Removal and Installation.

NOTE: Confirm the upper B-Pillar trim panel clips are installed properly [Fig. 1](#).
