REFERENCE:	TSB: 09-008-22 REV. D GROUP: 09 - Engine	Date:	October 28, 2023	REVISION:	09-006-23 REV. C
VEHICLES AFFECTED:	<p>2022 - 2024 (B1) Jeep Renegade 2022 - 2024 (H1) Jeep Commander 2022 - 2024 (M1) Jeep Compass</p> <p>This bulletin applies to vehicles equipped with a 1.3L I4 Turbo Mair DI Eng w/ESS E100 (Sales Code EYJ):</p> <ul style="list-style-type: none"> • **M1 built on and after April 28, 2021 (MDH 0428XX) and built on and before August 29, 2023 (MDH 0829XX). • H1 built on and after December 26, 2021 (MDH 1226XX) and built on and before August 29, 2023 (MDH 0829XX). • B1 built on and after January 14, 2022 (MDH 0114XX) and built on and before August 29, 2023 (MDH 0829XX).** <p>This bulletin applies to vehicles equipped with a 1.3L I4 Turbo Mair DI Engine w/ESS (Sales Code EYF):</p> <ul style="list-style-type: none"> • **M1 built on and after January 29, 2022 (MDH 0129XX) and built on and before August 29, 2023 (MDH 0829XX). • H1 built on and after March 25, 2022 (MDH 0325XX) and built on and before August 29, 2023 (MDH 0829XX). <p>This bulletin applies to B1 vehicles built on and after May 17, 2022 (MDH 0517XX) and built on and before August 29, 2023 (MDH 0829XX) equipp

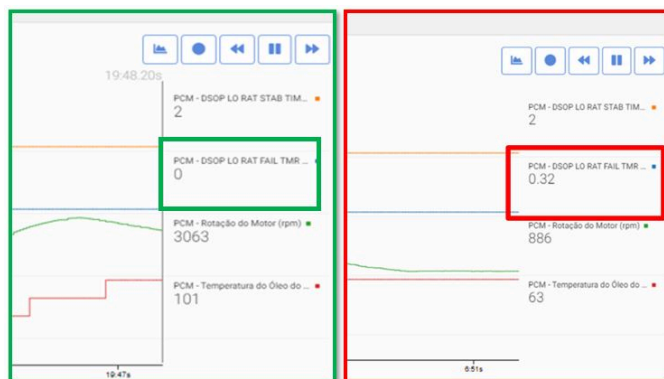
Fig. 1

- Using wiTECH check if DTC P06DD is set in the Powertrain Control Module (PCM).
- Was DTC P06DD found in the PCM?
 - YES>>> Replace the timing chain cover. Proceed to [Step 6](#).
 - NO>>> Proceed to [Step 3](#).
- **Start the engine at let it run at idle until the engine oil temperature reaches more than 100°C (212° F). Monitor for five seconds.
- Create a graph with “DSOP LO RAT FAIL TMR” and Oil Pressure (kPa) and review the value. If oil pressure is below 110 kPa, and or If “DSOP LO RAT FAIL TMR” shows anything but “0”, the timing cover needs to be replaced [Fig. 1](#).**

NOTE: The “DSOP LO RAT FAIL TMR” value can change in less than 20 seconds, then the oil pump (timing chain) is faulty and will need to be replaced.

Graph Showing Correct And Not Correct Values

- **Did the “Oil Pressure” value read is less than 110 kPa and/or “DSOP LO RAT FAIL TMR” value read anything but “0”?
 - YES>>> Create a screen shot of the graph showing values and attach it to the work order. Proceed to [Step 6](#).
 - NO>>> “Oil Pressure” value read is greater than 110 kPa and/or if the value always shows “0” and DTC P06DD was not found, this bulletin has been completed. Use Inspection LOP (09-65-01-74) to close the active RSU.**
- Replace the timing chain cover. Refer to the detailed service procedures available in DealerCONNECT/Service Library under: 09 - Engine, 1.3L I4 16V Multi Air Turbo / Valve Timing / Cover(s), Engine Timing / Removal and Installation.
- Using wiTECH clear any DTCs that may have been set.
