69 Airbag warning light on, DTCs B100A1B, B100B1B

69 23 05 2072349/1 December 13, 2023.

Model(s)	Year	VIN Range	Vehicle-Specific Equipment
Q5, Q5 e quattro, and SQ5	2020 – 2023		
Q5 Sportback, and SQ5 Sportback	2021 - 2023	All	Not Applicable

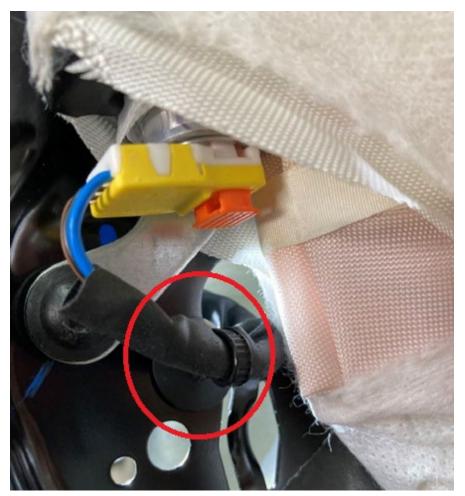
The wire harness of the side/thorax airbag is too close to the seat foam. The seat foam presses on the wire harness causing movement of the airbag connector, resulting in an increase in electrical resistance.

Figure 1. Install additional zip tie/clip when installing new thorax airbag wire harness.

- 1. Replace the affected side/thorax airbag wire harness(es) according to: Elsa>>Repair manual>>Body>>Body Interior>>Passenger Protection, Airbags, Seat Belts>>Thorax Airbags>>Thorax Airbag Wire, Removing and Installing.
- Route the new thorax airbag wire harness(es) as close to the seat frame as possible. To do so, use zip tie/clip N10546701 (Figures 1, 2).

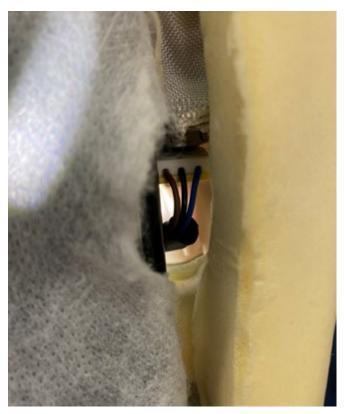
Figure 2. Route new thorax airbag wire harness as close to seat frame as possible.
