Technical Service Bulletin

90 Instrument cluster: status display in the driver information system is empty 90 23 60 2072306/1 December 11, 2023.

Model(s)	Year	VIN Range	Vehicle-Specific Equipment
A5, A5 Cabriolet, A5 Sportback, S5, S5 Cabriolet, S5 Sportback, RS 5, RS 5 Sportback, Q5, Q5 e quattro, Q5 Sportback, SQ5, and SQ5 Sportback		All	Analog instrument cluster

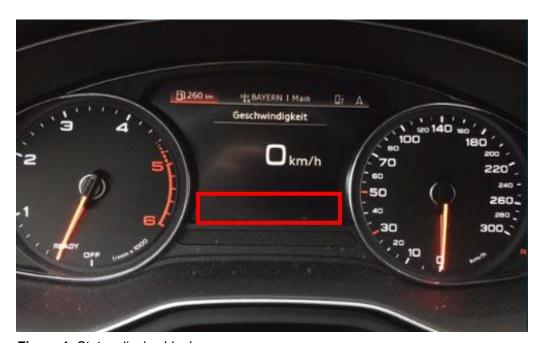
Sporadically the content of the status display is not shown for any of the tabs (Vehicle functions, Driver messages, Radio, Media, Phone, Navigation).

Workshop Findings: The status display returns after a sleep cycle, no DTC is associated with the blank display (Figure 1).

Figure 1: Status display blank.

Software issue in instrument cluster.

- 1. Follow all instructions in TSB 2011732: 00 Software Version Management (SVM), operating instructions.
- 2. Update the Instrument cluster J285 (address word 0017) using the SVM action code as listed in the table below, if necessary:
