Technical Service Bulletin

90 Instrument cluster: status display in the driver information system is empty

90 23 61 2072306/2 December 13, 2023. Supersedes Technical Service Bulletin Group 90 number 23-60 dated December 11, 2023 for reasons listed below.

Model(s)	Year	VIN Range	Vehicle-Specific Equipment
A5, A5 Cabriolet, A5 Sportback, S5, S5 Cabriolet, S5 Sportback, RS 5, RS 5 Sportback, Q5, Q5 e quattro, Q5 Sportback, SQ5, and SQ5 Sportback	2022 – 2023	All	Analog instrument cluster

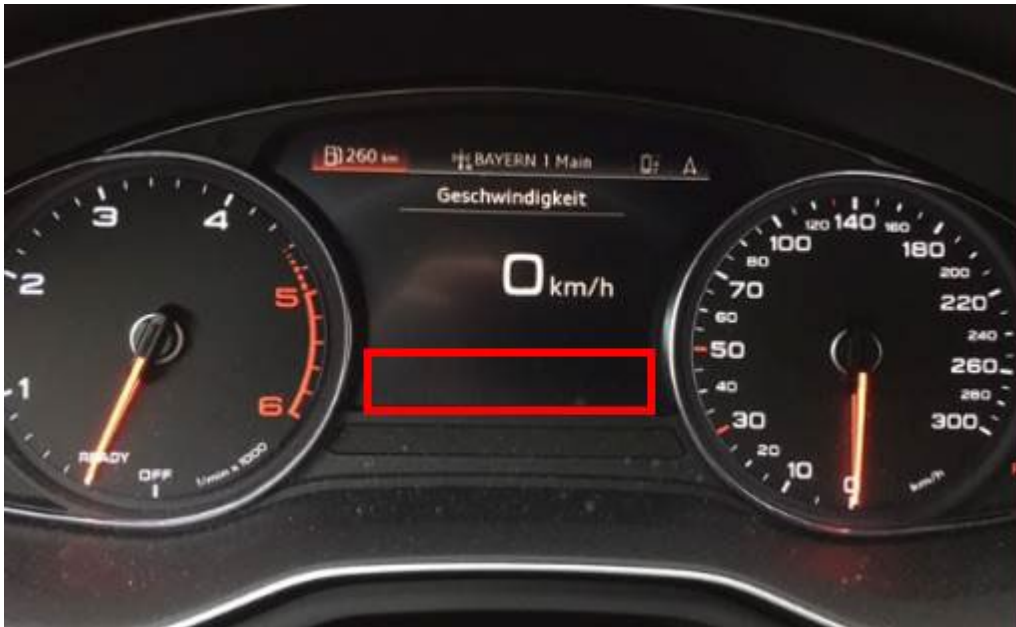
Sporadically the content of the status display is not shown for any of the tabs (Vehicle functions, Driver messages, Radio, Media, Phone, Navigation).

Workshop Findings: The status display returns after a sleep cycle, no DTC is associated with the blank display (Figure 1).

Figure 1: Status display blank.

Software issue in instrument cluster.

1. Follow all instructions in TSB 2011732: *00 Software Version Management (SVM), operating instructions.*
2. Update the Instrument cluster J285 (address word 0017) using the SVM action code as listed in the table below, if necessary:
