Service Action

Code: 34L4

Subject	Transmission Control Module (TCM) Software				
Document History	Date		Summary		
	12/14/2023		Updated parts and claiming information		
	11/03/2023		Updated repair steps after software update is completed. Added example photos of transmission damage.		
	08/03/2023		Original publication		
Affected Vehicles	Country	Beginning Model Year	Ending Model Year	Vehicle	Vehicle Count
	USA	2017	2018	A3 CABRIOLET	713
	USA	2017	2018	A3 SEDAN	7,898
	USA	2018	2018	S3 SEDAN	589
	CAN	2017	2018	A3 SEDAN	515
	CAN	2018	2018	S3 SEDAN	115
	<p><i>Check Campaigns/Actions screen in Elsa on the day of repair to verify that a VIN qualifies for repair under this action. Elsa is the <u>only</u> valid campaign inquiry & verification source.</i></p> <ul style="list-style-type: none"> ✓ Campaign status must show "open." ✓ If Elsa shows other open action(s), inform your customer so that the work can also be completed at the same time the vehicle is in the workshop for this campaign.

About this Service Action	Audi is providing updated transmission control module (TCM) software to enhance an in-vehicle alert should a problem arise within the auxiliary hydraulic pump. Additionally, i

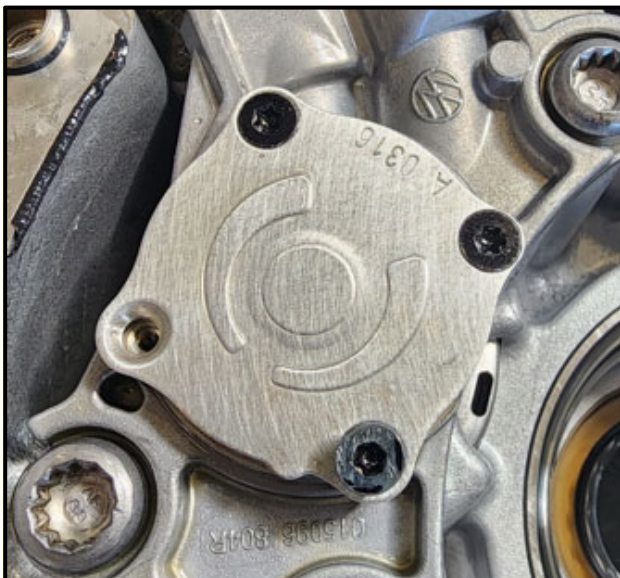
If internal or external damage caused by the auxiliary hydraulic pump bolts coming loose is found before or during the repair:

A missing bolt or damaged bolt is considered internal transmission damage.

- Take clear photos
- U.S. dealers: Upload photos of the damage to Doc-It for review. Contact Audi warranty for authorization.
- Canadian dealers: Create a TAC WEB ticket with the photos attached for review.
