# Technical Service Bulletin

**55 Power rear lid cannot be opened**  
55 23 86 2072431/1 December 15, 2023.

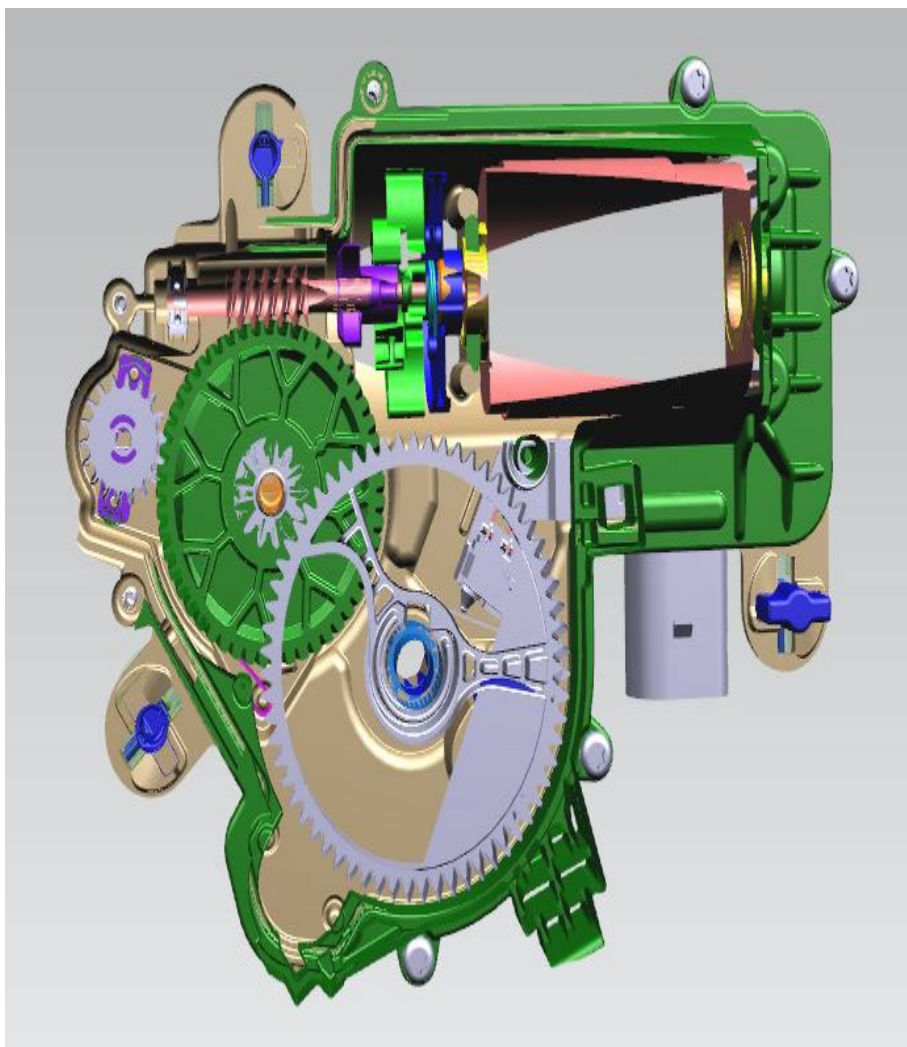
Due to component-related deviations of the rear lid closing assist motor, the closing assist motor can be internally blocked. Consequently, the power rear lid can no longer be opened as the rotary latch of the rear lid lock is not released by the closing assist motor (Figure 1).

**Figure 1.** Rear lid closing assist motor.

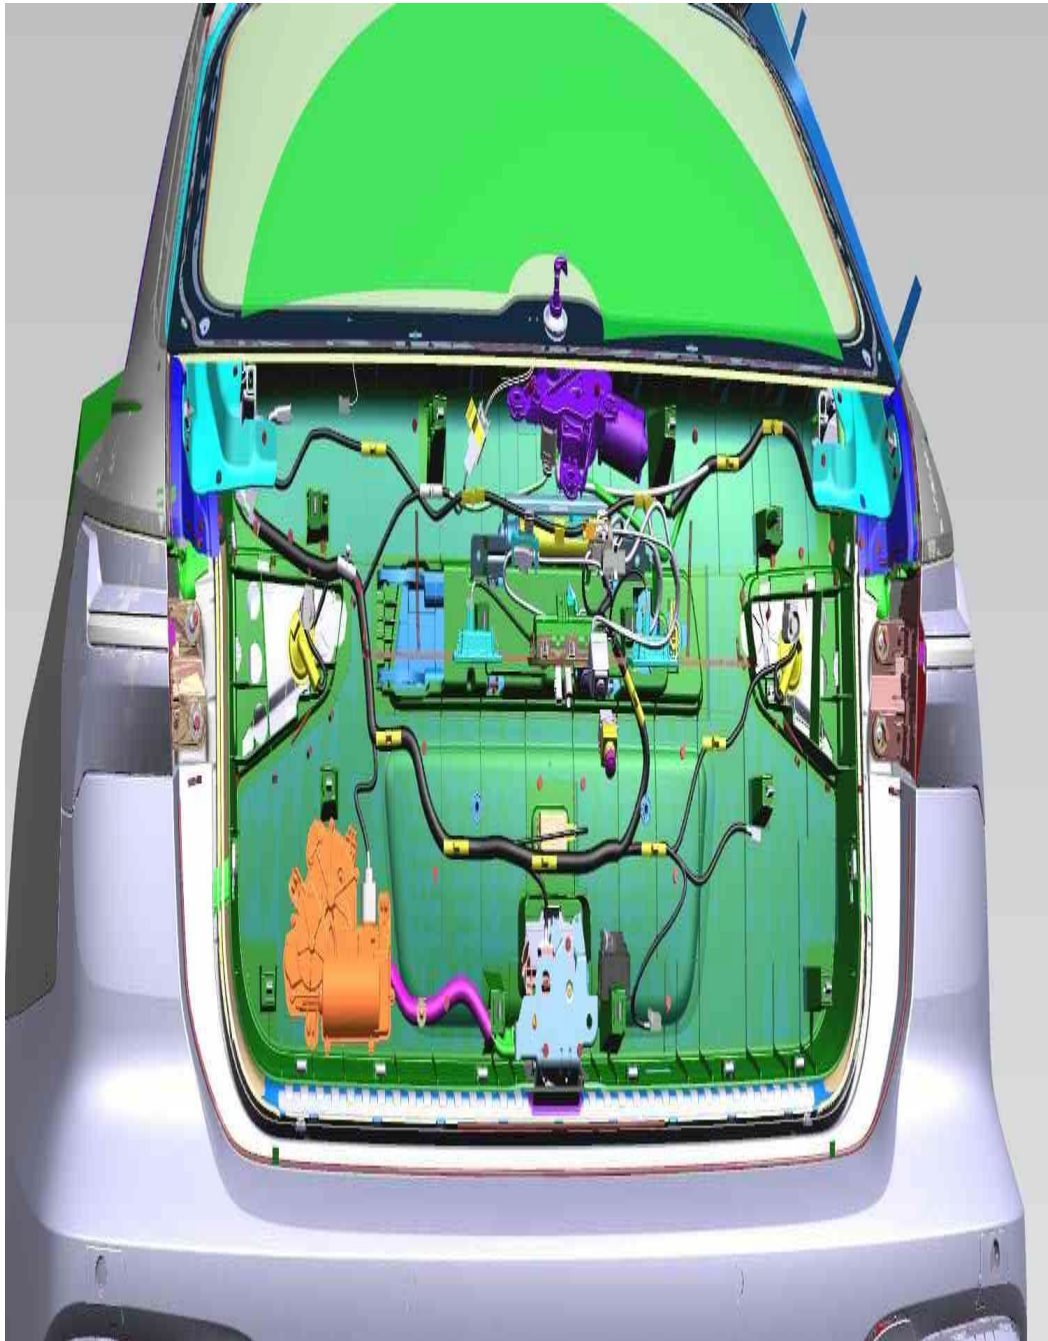
**Figure 2.** Carefully knock in the area of the closing assist motor (highlighted in orange). Its location varies and is model specific.

1. If it is not possible to open the power rear lid using the vehicle key, the interior/exterior buttons, or the emergency release, carefully knock with your hand on the rear lid in the area of the closing assist motor (Figure 2). The resulting vibration should release the blockage within the closing assist motor.

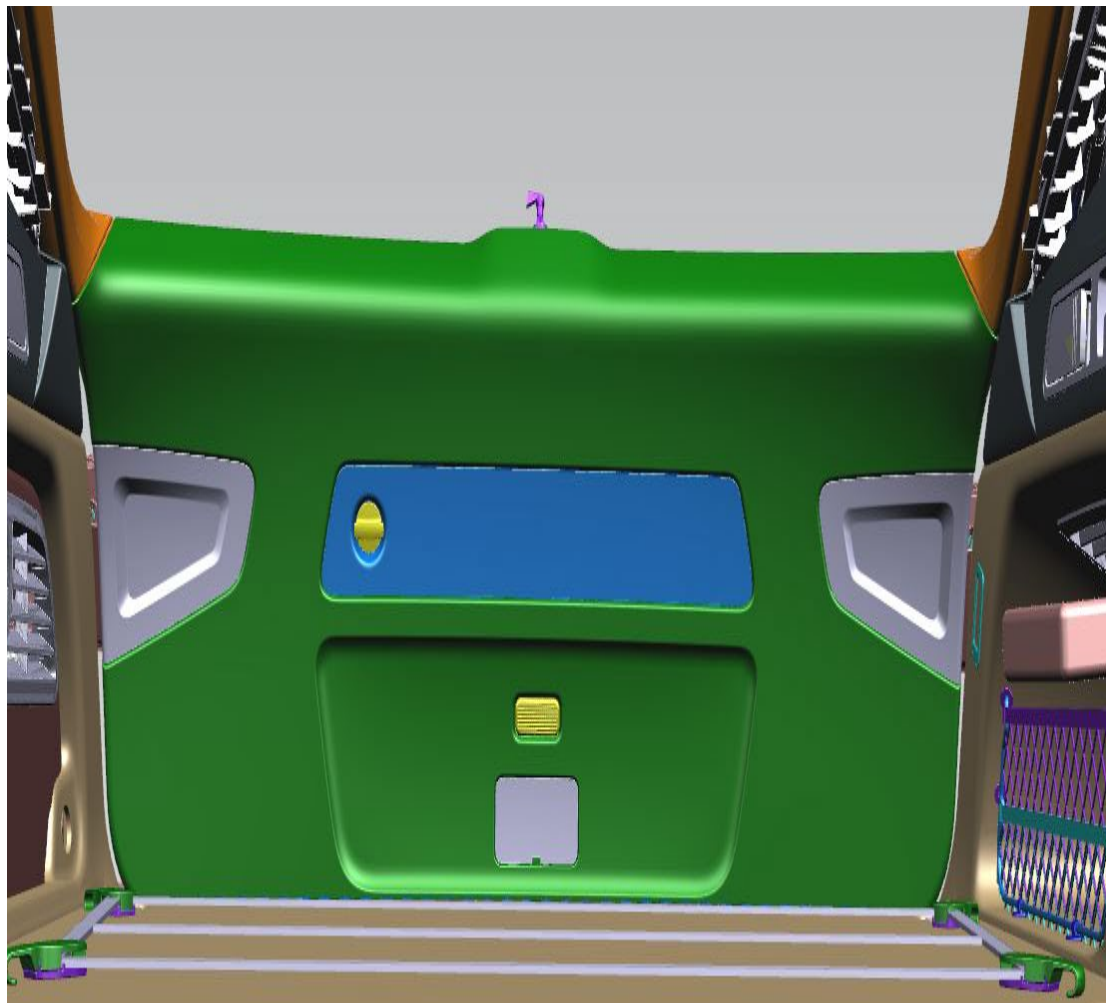
*Figure 3. Lower rear lid trim panel of an RS 6 avant.*

3. Replace the closing assist motor.
4. If the blockage within the closing assist motor cannot be released and the latch of the rear lid remains blocked, the rear lid lower trim panel must be removed using standard tools. On some models it is not possible to remove the trim panel without damaging it irreparably. (Figure 3).

Please upload a photo of the damaged trim panel to Doc-It.
