Service Bulletin

Bulletin No.: 23-NA-107

Subject: Roof Related Water Leak, Shifter Light Inoperative, Key Fob Inoperative and/or Various Remote Control Door Lock Receiver (RCDLR) Concerns

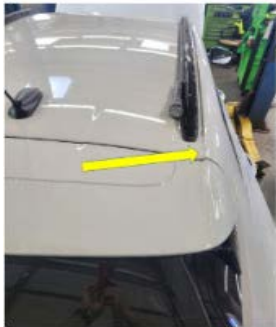
6370899

The cause of the condition may be a pin hole / poor sealing in the roof body seam or poor brazing weld. This condition could occur at either the front and/or rear, and on the right and/or left side or cross rail front stud not sealing to body of the vehicle.

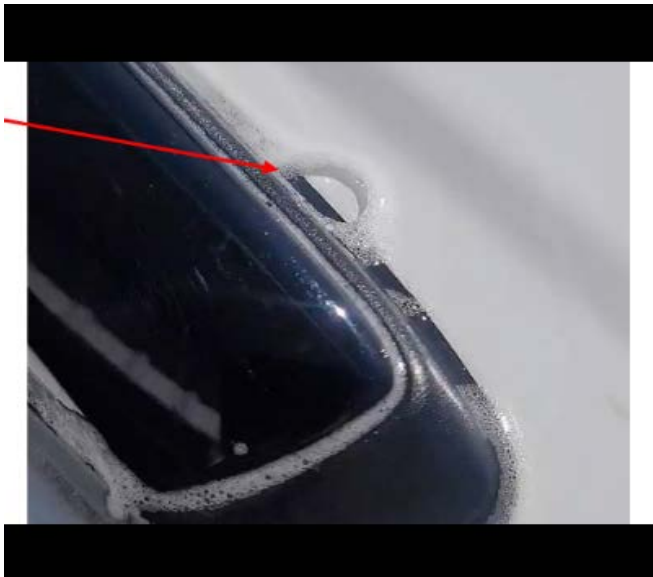
6445101

1. Visually inspect the front right and left roof laser braze, then the rear right and left roof laser braze, for pin holes or a crack.

2. Seal the holes/crack in any laser braze area following the steps below:
 - 2.1. Mix a small amount of Kent® High-Tech Seam Sealer Clear P10200, or Wurth Euroseal Gel Clear 18920104, or equivalent WITH the proper touch-up paint color.

- 2.2. Avoiding excess sealer build-up within the ditch, work a small amount of the sealer into the hole with a gloved finger.
 - 2.3. Wipe away any excess sealer with a light amount of solvent on a rag or paper towel. The solvent will help the sealer flow into the hole/crack.
