00-19-01 - PDI - Paint Defect - Water Migration Under the RAPGARD®

Release date: 12/14/2023

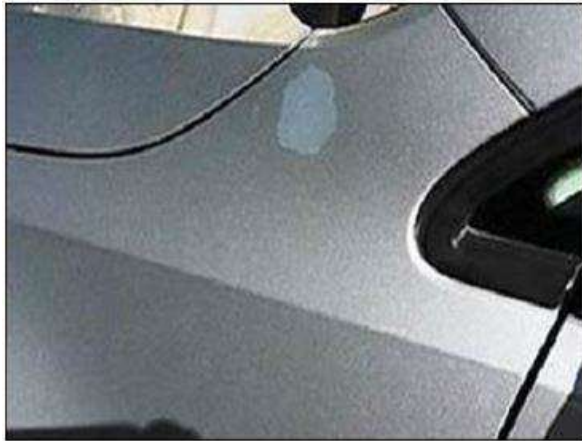
Example 1

Water migration under the RAPGARD® can be mistaken as a paint defect when in fact it is only moisture trapped in the clear coat of the paint. See examples 1-12 to see how water migration may appear.

After removal of RAPGARD®, some vehicles may exhibit temporary paint discoloration or paint swelling (caused by trapped moisture under the RAPGARD®).

Paint discoloration (looks like shaded or dark magic marker lines) can be removed with a heat gun using the following procedure:

- Hold heat gun approximately 3 in. away from affected paint surfaces and apply heat using slow oscillating motions until discoloration is gone.
- If discoloration remains, wipe the heated area with Isopropyl alcohol and repeat procedure to increase surface drying.
