# Service Bulletin

Bulletin No.: 23-NA-177

**Subject: Setting for Hands Free Liftgate (Open-Close) is Setting to 'Off' During Ignition Cycles**

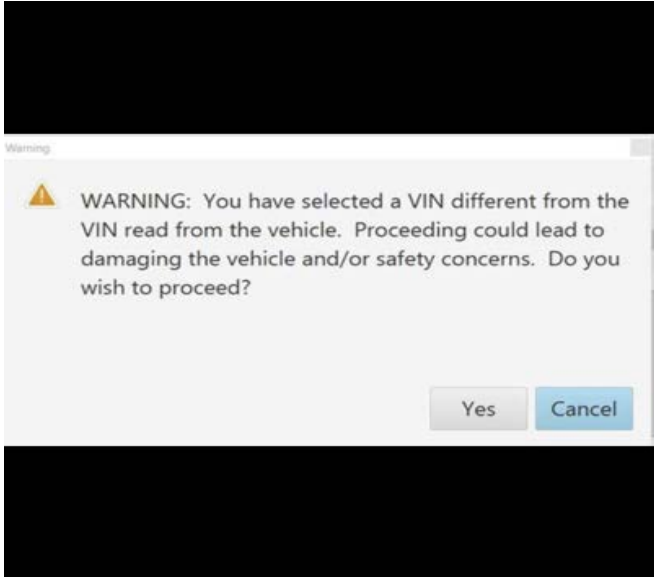
**Important:** If the vehicle VIN DOES NOT match, the message below will be shown
