Service Bulletin

Bulletin No.: 23-NA-201

Subject: Loss of Steering Assist and/or Loss of Brake Assist Malfunction Indicator Lamp (MIL) Illuminated - DTCs P25A2, U0422, C1595, U0420, C116C, B3205, B127B and/or B1325 Set

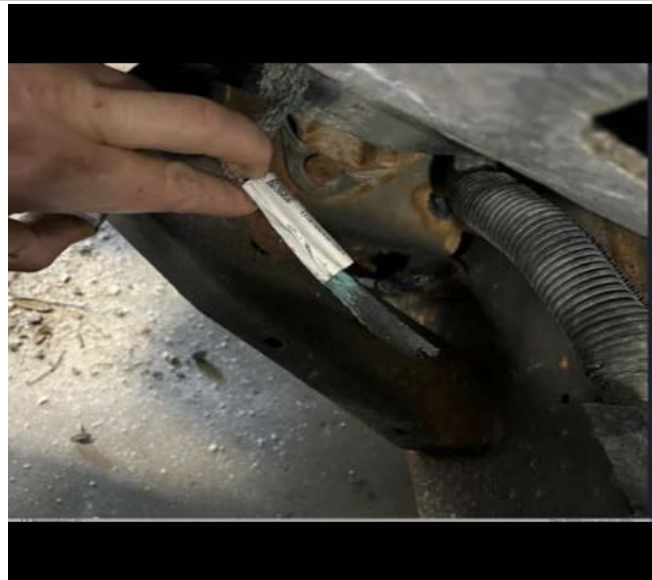
6483337

This condition may be caused by High resistance in the G132 and G133 grounds, located behind the RH wheelhouse liner.
