Service Bulletin

Bulletin No.: 23-NA-218

Subject: Rear Side Door Weatherstrip Coming Loose

Brand:	Model:	Model Year:		VIN:		Engine:	Transmission:
		from	to	from	to		
Chevrolet	Trailblazer	2021	2024	—	—	—	—

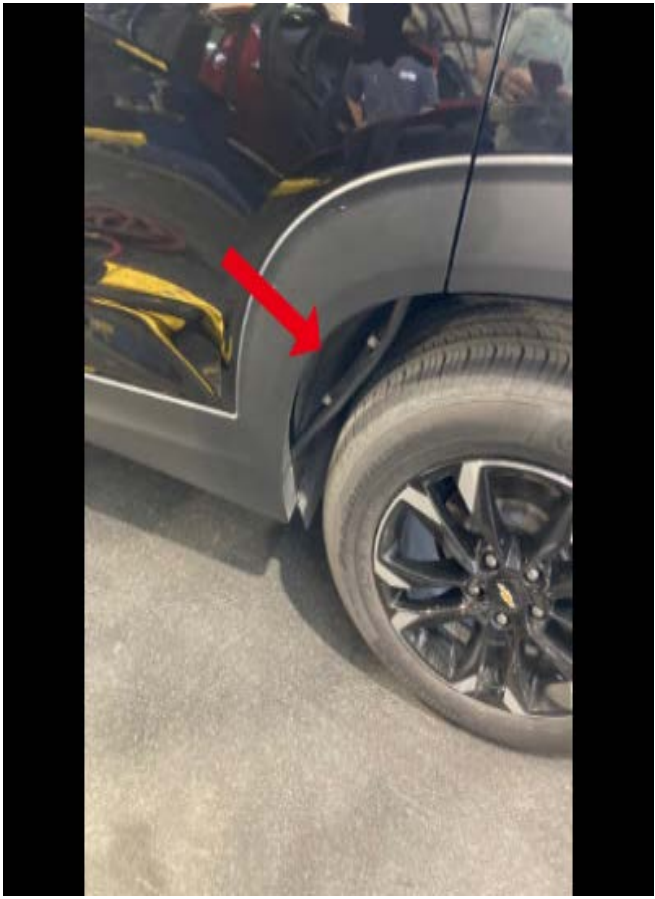
<p style="text-align: right;">6497432</p>
Cause	Some customers may comment on the seal or weatherstrip coming loose from the rear door. The cause of the condition may be that the weatherstrip is seated loosely on its three plastic clips and can slide off.
