SIB 52 19 23

SECOND ROW 60/40 SEAT RAIL FLEX CABLE REPLACEMENT

E-Series	Model Description	Affected Option Code
G07	X7 Sports Activity Vehicle	7-passenger vehicle equipped with second row 60% / 40% split seat

G07 (X7) SECOND ROW 60/40 SEAT RAIL
ATTACHMENT TO SERVICE BULLETIN 52 19 23 – DECEMBER 2023

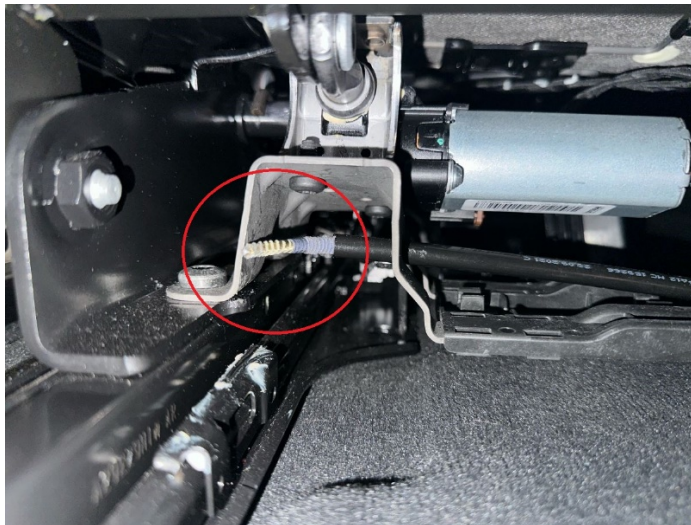
In vehicles equipped with the second row 60% / 40% split seat, the flex cable assembly can come out of the seat rail mechanism (circled). This stops the forwards and backwards travel of the seat.

Something has mechanically jammed the seat movement on one or both sides of the seat.

Locate and remove the foreign object, if still present.

Replace only the damaged flex cable assembly instead of entire seat rail assembly.

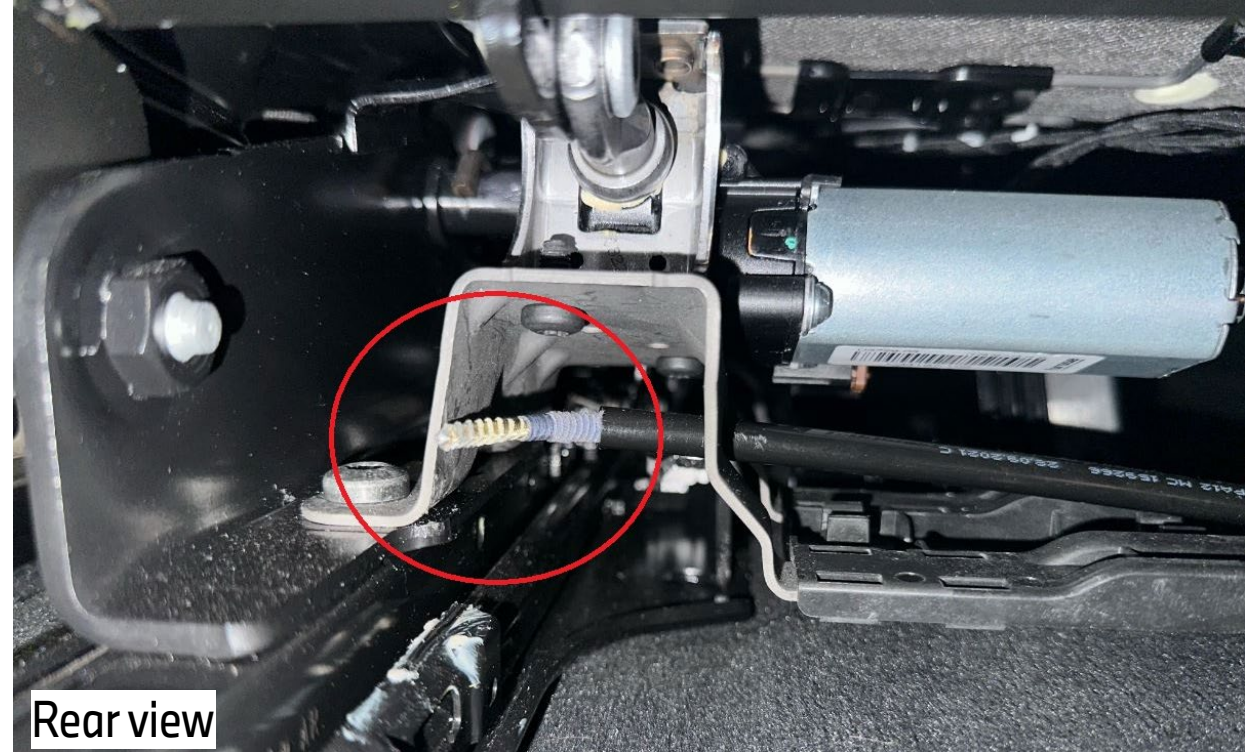
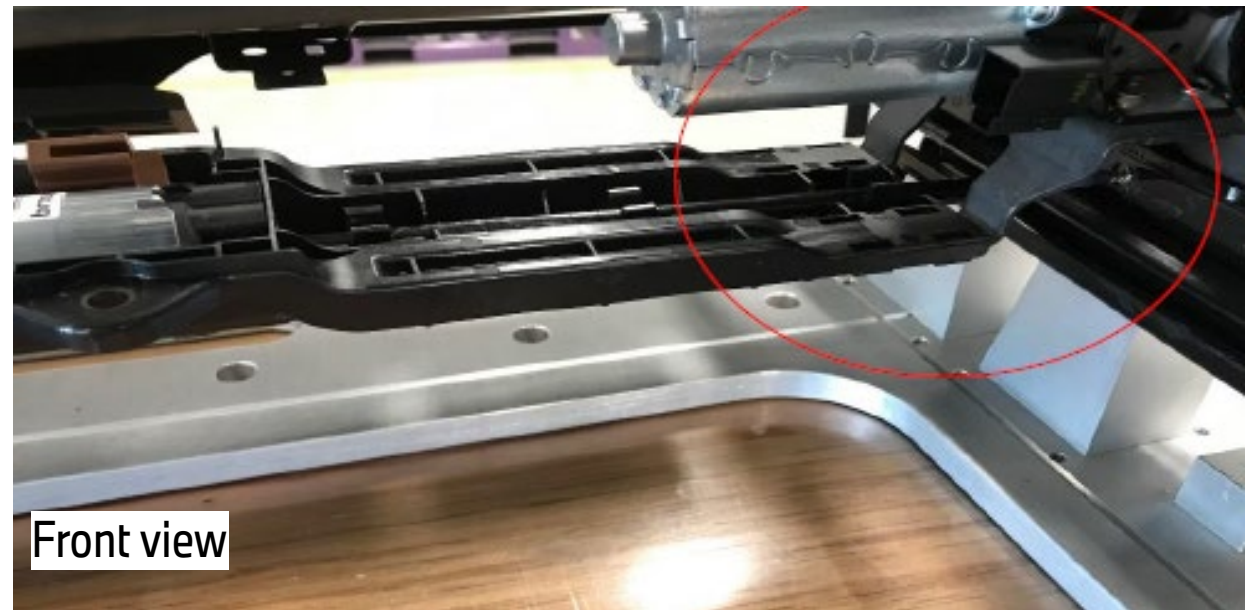
In this example the 60% seat inboard flex cable has come out of the seat rail gearbox.

This will stop the seat from moving forwards and backwards on the rails.

3. To make this repair the inboard flex cable and cover tube needs to be completely removed from the motor carrier tray and replaced. This will be shown in the next steps.
