SIB 61 30 23

## DELIVERY STOP: INTERACTION BAR

| E-Series | Model Description | Production Date |
|---|---|---|
| G70 | 7 Series Sedan | November 10, 2022 – March 28, 2023 |

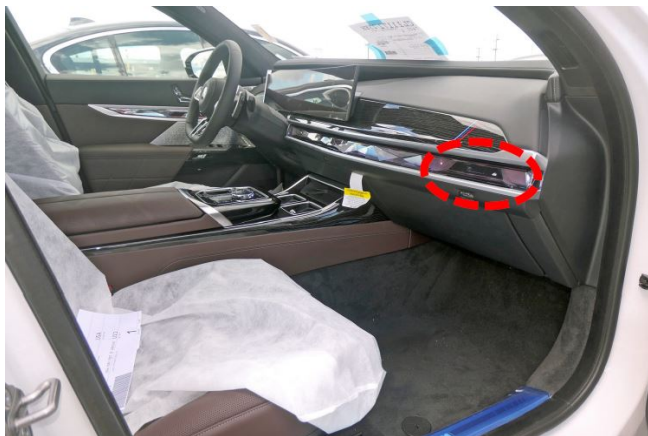
In the event of a voltage drop, comfort functions of the interaction bar may fail and not respond.

Software error in the BMW Interaction Bar.

This can lead to a failure of the air vent functions on the passenger side of the bar (circled).

Replace the BMW Interaction Bar **before vehicle delivery**.

Replace the BMW Interaction bar following repair instructions, **Removing, and installing the touch control box for the instrument panel 61 31 147 | REP-REP-P-6131147-G70 - V.4.**
