SIB 52 18 23

NOISE HEARD FROM SEAT MOTOR WHEN MOVING THE FRONT SEAT

E-Series	Model Description
G01	X3 Sport Activity Vehicle
G02	X4 Sport Activity Vehicle

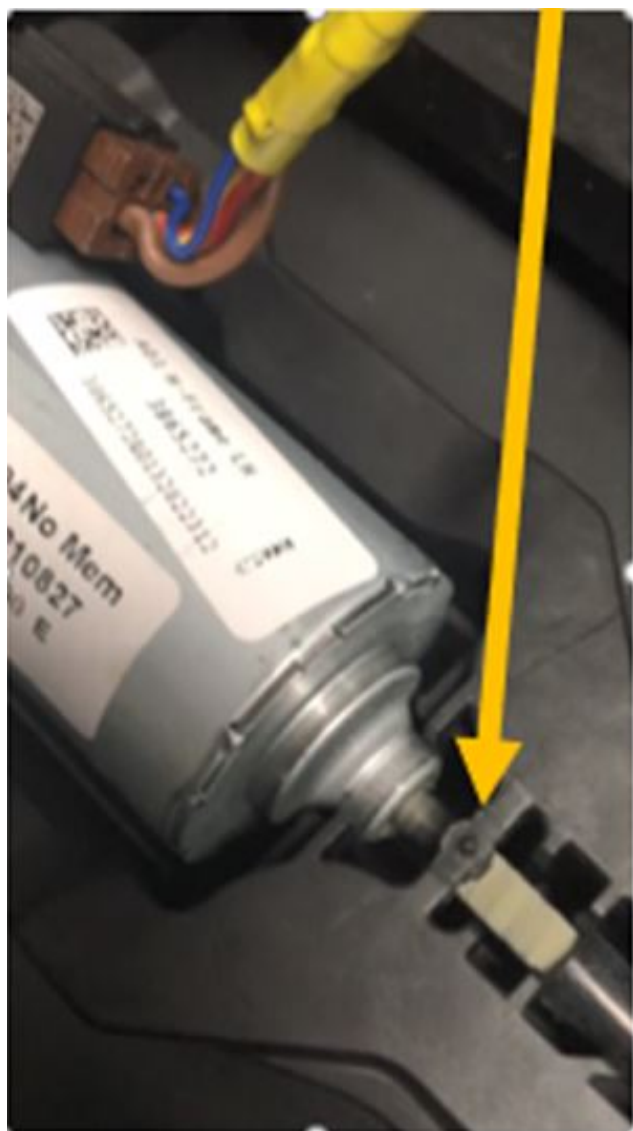
The electric motor for forward/back seat adjustment (SLV motor) may have become loose from its plastic mounting tray, allowing the drive cable mechanism to rub (arrow).

Make sure the motor for the forward/back seat adjustment is properly sitting in the plastic tray. Secure it in place with a plastic zip tie (aka cable strap).

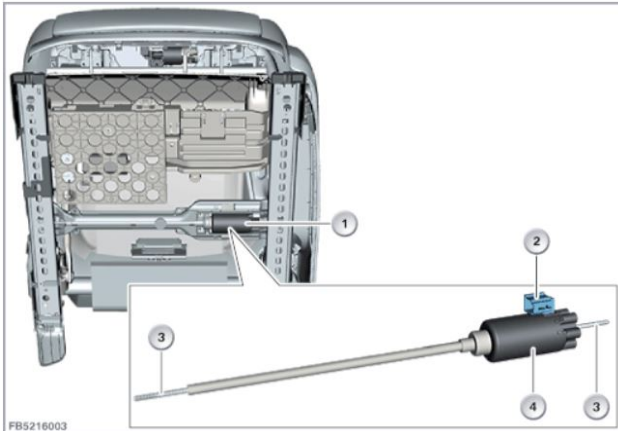
1. Make sure the electric motor for forward/back seat adjustment is properly sitting in the plastic tray.

- 1= Forward/back seat adjustment motor
- 2=Electrical connection
- 3=Spindle (drive cable)
- 4= Motor

1. Move the seat bottom to highest position to allow access underneath.
