SIB 52 17 23 SEAT MODULE INOPERATIVE, FUSE BLOWN

2023-12-11

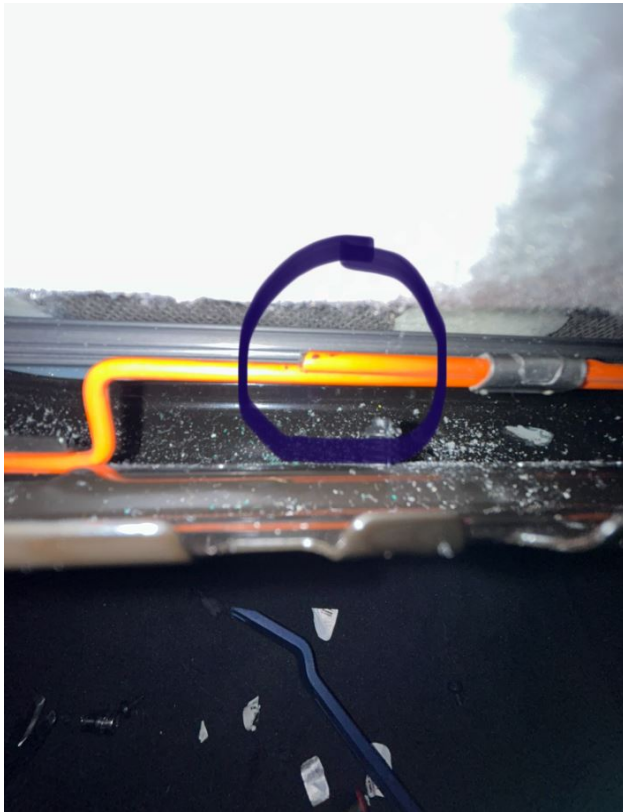
Seat harness short-circuits against the orange spring assembly at the bottom of the seat backrest.

Locate the harness damage. Repair the harness, if possible; or replace if necessary. Put felt tape around the orange seat spring ends to prevent future damage.

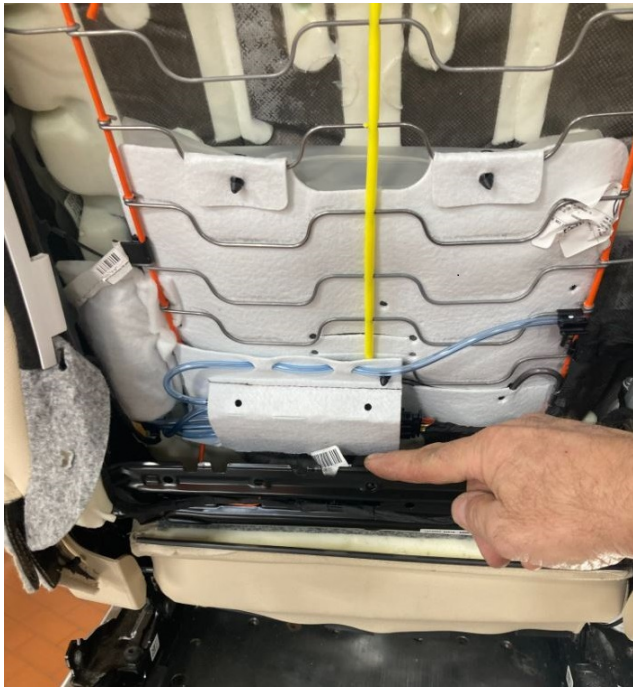
Remove the seat backrest cover. Check the wiring harness as it routes along the bottom of the seatback to observe if it is shorting on the orange spring assembly at the bottom of the seat backrest.
