SIB 51 10 22

GROANING NOISE IN THE LUGGAGE COMPARTMENT AREA

This Service Information Bulletin (Revision 1) replaces SI B51 10 22 **dated June 2022**.

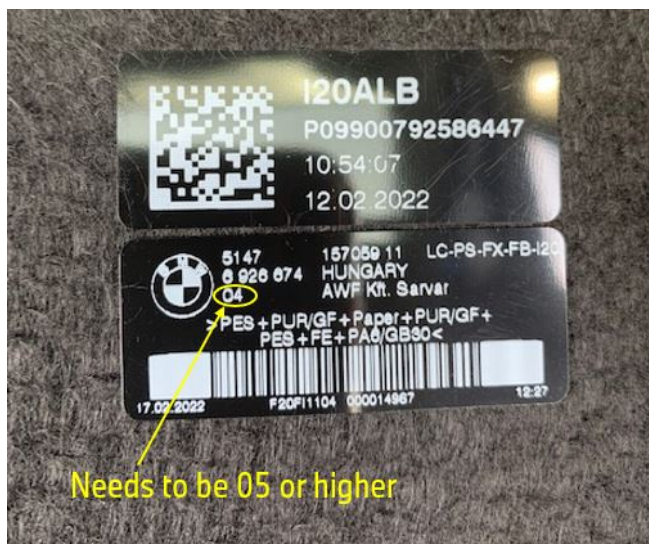
The AI (revision index) of the new part must be 05 or higher (circled).

Replace the front parcel shelf with part number **51 47 6 926 674, AI (revision index) 05 or higher**.

- Verify the customer's complaint.
- If the noise reproducible with the front parcel shelf installed, then the shelf will need to be replaced with part number **51 47 6 926 674**.
