Service Bulletin

Bulletin No.: 23-NA-220

Subject: Rattle or Vibration Noise Coming from Upper Dash - Windshield Area While Driving

Brand:	Model:	Model Year:		VIN:		Engine:	Transmission:
		from	to	from	to		
Cadillac	XT4	2024	2024	-	-	All	All

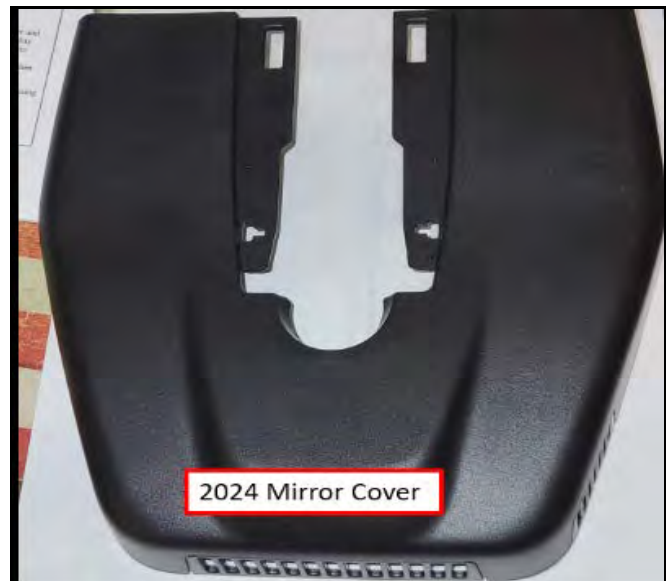
6488112

Involved Region or Country	North America, Middle East
Condition	Some customers may comment on a rattle / vibration noise coming from the upper dash area while driving.
Cause	The cause of the condition may be the fitment of the windshield multifunction sensor mount bracket cover insert with the cover.
Correction	If you encounter a vehicle with the above concern complete the procedure below.

Dealers are to remove the insert from the cover. (see below).
