Subject: Engineering Information - Check Engine Lamp Illuminated on Driver Information Center (DIC), DTC P2B97 Set

Brand:	Model:	Model Year:		VIN Breakpoint:		Engine:	Transmission:
		from	to	from	to		
Chevrolet	Silverado 1500	2023	2024	—	—	Equipped with 3.0L (RPO LZ0)	—
GMC	Sierra 1500

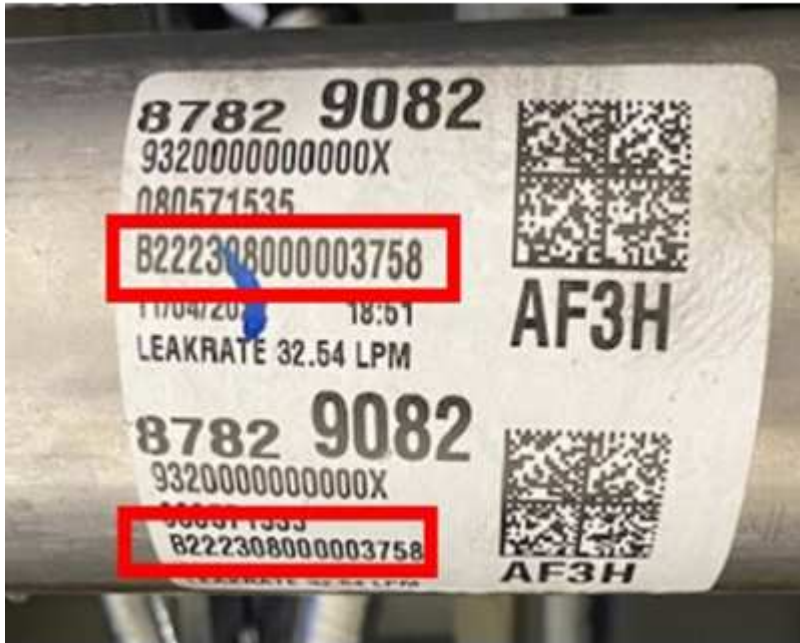
1. Take a picture of the serial number on the exhaust pipe, as shown in the picture above.
2. What is the Exhaust Pressure Regulator Valve Learned Position **PRIOR** to replacement?
3. What is Exhaust Pressure Regulator Valve Learned Position **AFTER** replacement?
4. If the two-valve learned position are within 12% (smallest number divided the highest number times 100), disconnect the exhaust rear pipe from the rest of the exhaust with the actuator wires connected.
 - 4.1. Using a bore scope, examine the valve inside of the pipe as the valve is commanded open and closed.

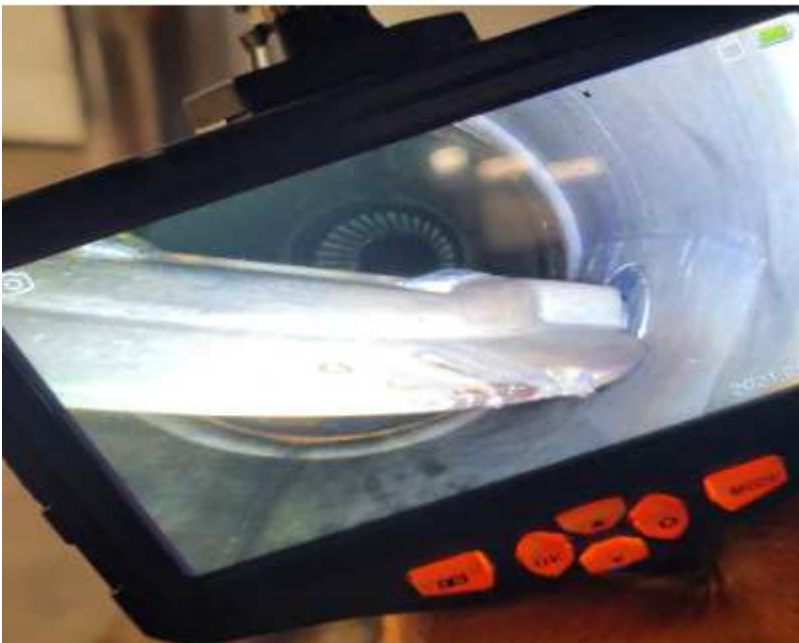
- 4.2. Check if the shaft rotates freely and make sure that the flap is not binding or sticking due to any debris, dirt, ice, or welding spatter, as shown in the pictures above.
