Subject: Engineering Information - (EI Lite) - (Pictures Only) Lower Oil Pan is Leaking Oil

Brand:	Model:	Model Year:		VIN Breakpoint:		Engine:	Transmission:
		from	to	from	to		
Chevrolet	Silverado 1500	2023	2024	—	—	Equipped with 3.0L (RPO LZ0)	—
GMC	Sierra 1500

Lower Oil Pan is Leaking Oil

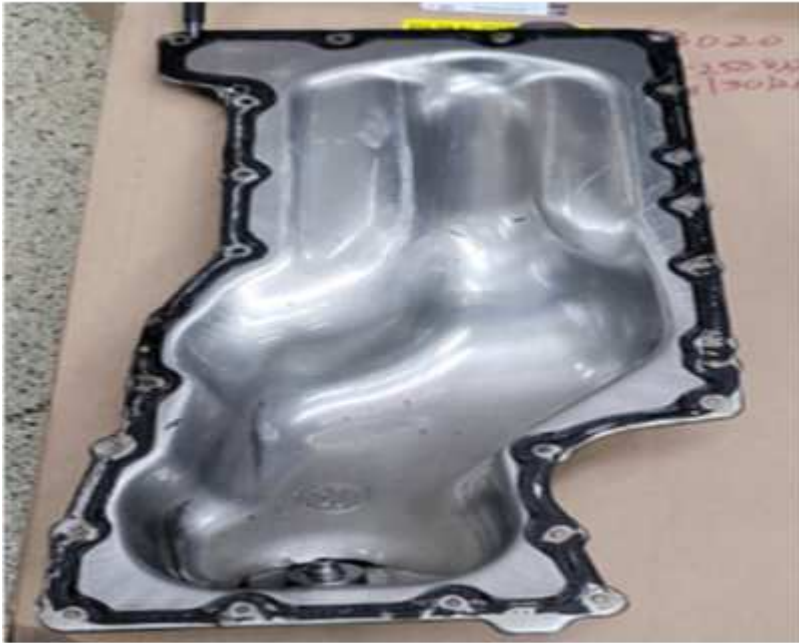
2. Take one or more pictures of the entire sealing surface of the pan dismounted, as shown in the picture above. (NOT REMOVE the RTV from the surface)

Important: DO NOT remove any of the RTV from the surface.

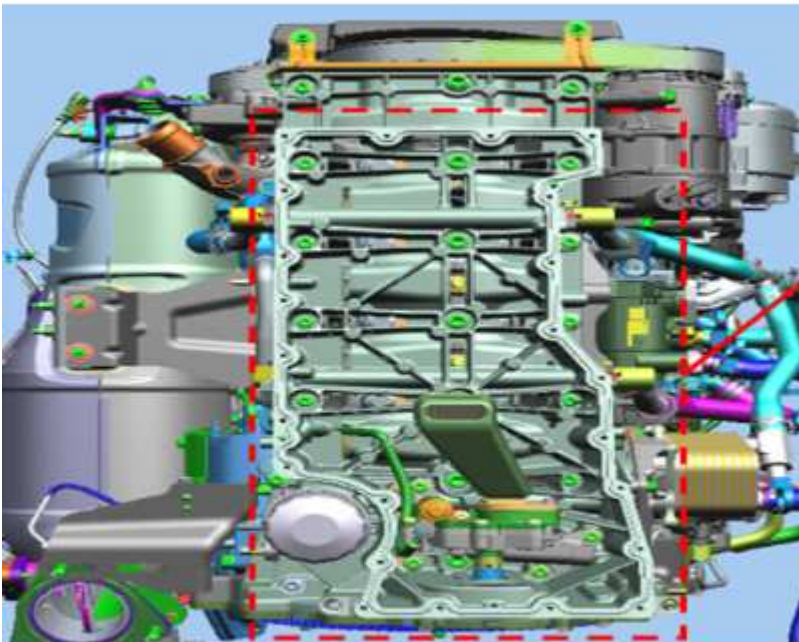
3. Take one or more pictures of the LCE sealing surface, as shown in the picture above. (NOT REMOVE the RTV from the surface)

Important: DO NOT remove any of the RTV from the surface.
