PIT5950A Diagnostic Tip - Repeat Front Wheel Speed Sensor DTC After Sensor Replacement - ABS Traction Stability Control MIL DTC C0505 C050B C0511 C0517 C0501 C0502 C0503 C0504 C0507 C0508 C0509 C050D C050E C050F C0510 C0513 C0514 C0515 C0516 and/or C050A

Brand:	Model:	Model Years:	VIN:		Engine:	Transmissions:
			from	to		
Chevrolet	Silverado 1500 (New Model)	2019	All	All	All	All
Chevrolet	Silverado 1500	2020 - 2024	All	All	All	All
GMC	Sierra 1500 (New Model)	2019	All	All	All	All
GMC	Sierra 1500	2020 - 2024	All	All	All	All

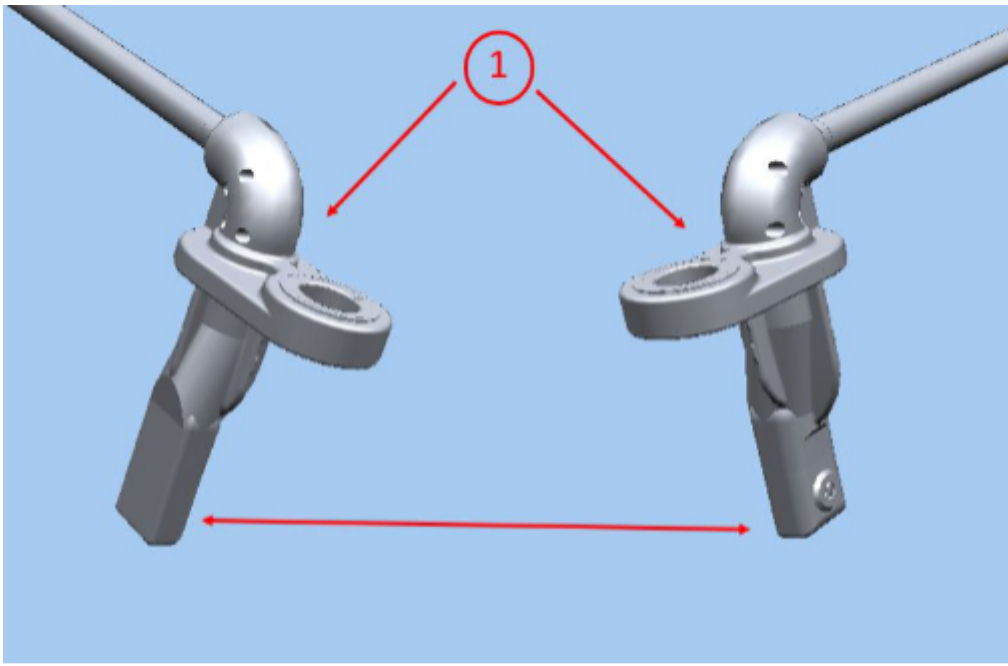
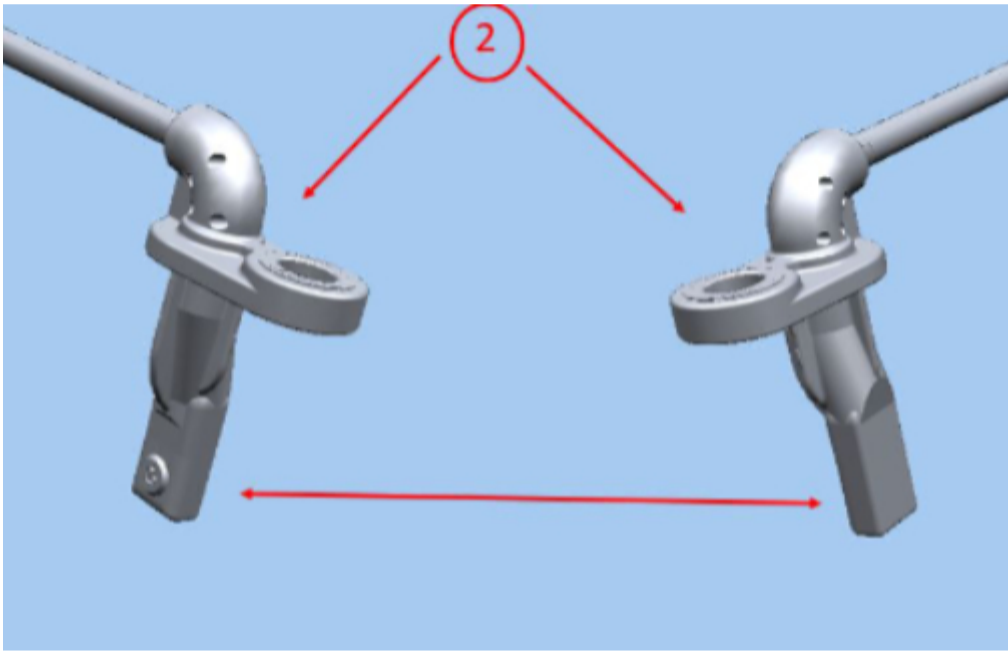
Involved Region or Country	North America
Condition	<p>When replacing a front wheel speed sensor (WSS) it is critical that the correct part number WSS sensor be installed for it to properly sense the magnetic encoder ring located on the wheel bearing assemblies.</p> <p>The Right (1) and Left (2) front WSS, shown below, look very similar and there have been many cases where the wrong sensor has been installed.</p> <p>An example would be a right WSS installed on the left side of the vehicle.</p> <p>Subsequently, several unnecessary parts are replaced, such as, Brake System Control Modules, wheel bearings, additional wrong WSS, pigtail connectors, etc.</p>
Cause	Incorrect part number WSS installed.

If a front WSS is replaced and you continue to set WSS DTC(s) for the same side, then check to make sure the correct part number front WSS was installed.

Inspect the tip of the WSS to ensure the flat side of the sensor tip is orientated towards the wheel bearing magnetic encoder ring.
