MAS003773 RU 23-51

# Rapid Update 664 Granturismo – Replacement of front A-pillar coverings

DATE: NOVEMBER 23 2023

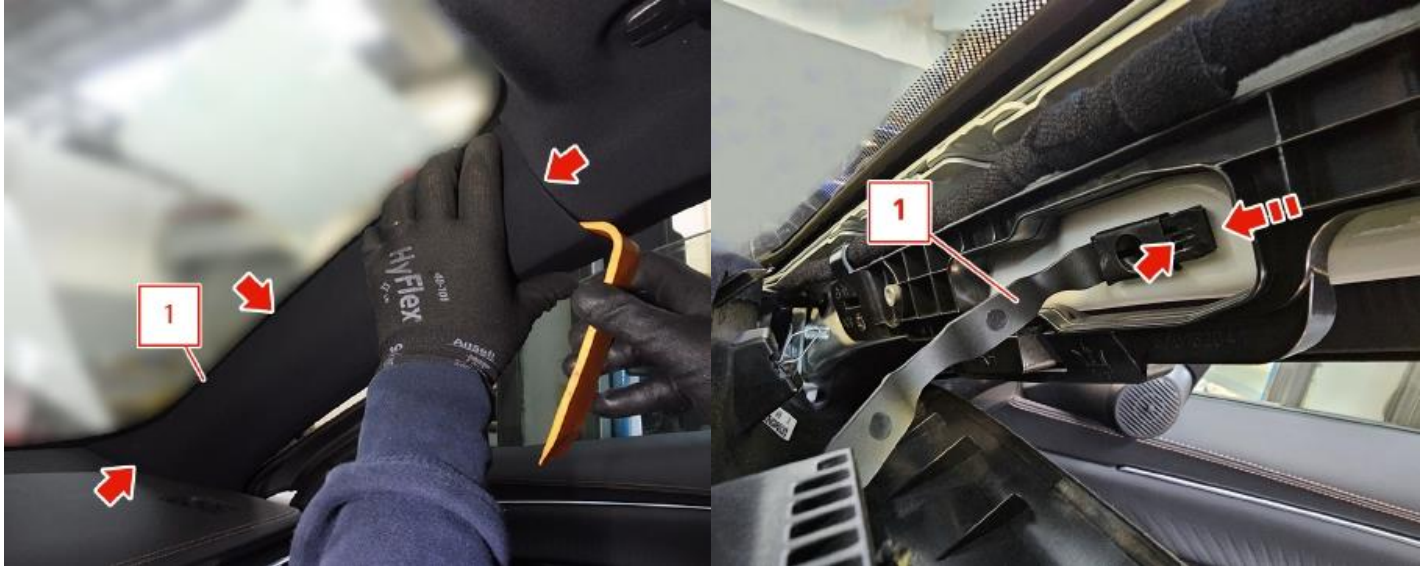
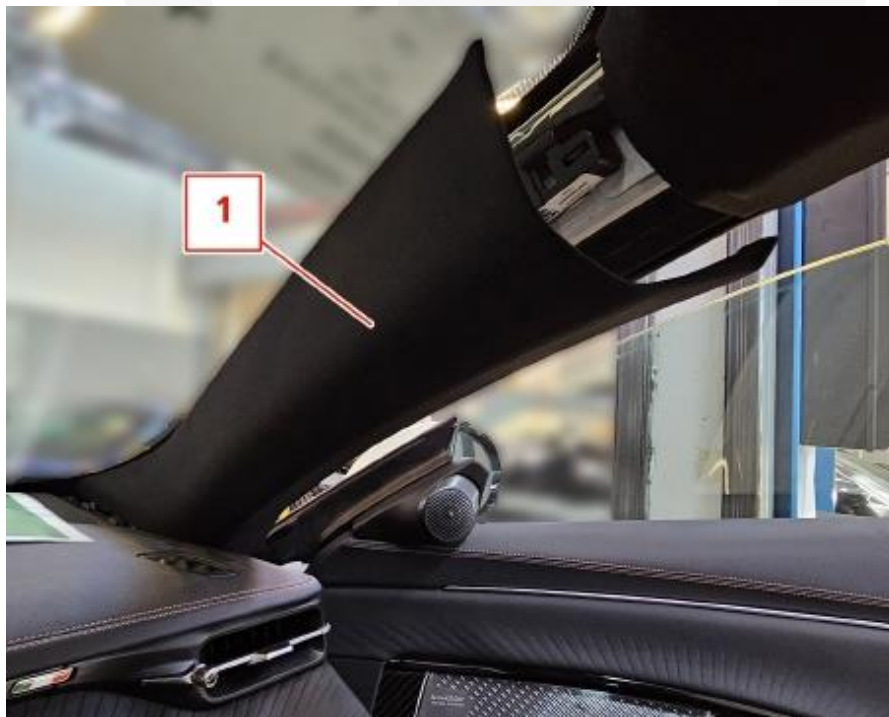
This action is deemed necessary due to the identification of a limited batch of components that have been installed. There is a concern regarding potential fabric wrinkles resulting from a deviation in the manufacturing process. The procedure therefore consists in replacing the existing components with new ones.

1. Always check ModisCS+ to see if the vehicle is involved in this action and if it has not been previously performed.
2. Always add interior protection to protect the interior.
3. Replace both A-pillars following the procedure in the workshop manual:
  - **09.44.001 RIGHT WINDSHIELD PILLAR COVERING. Removal-Reattachment or Replacement**
  - **09.44.002 LEFT WINDSHIELD PILLAR COVERING. Removal-Reattachment or Replacement**

4. Repeat the operation on the other side. (Both A-pillars)
5. Re-install all removed parts following the procedure in reverse order.
6. Procedure complete.
