## Rapid Update 668 Grecale – Door Seals Check

DATE: NOVEMBER 29 2023

Certain Maserati Grecale (M182) MY23 listed in MODISCS+ are involved in a Rapid Update to check the front and rear door gaskets (All 4 doors).

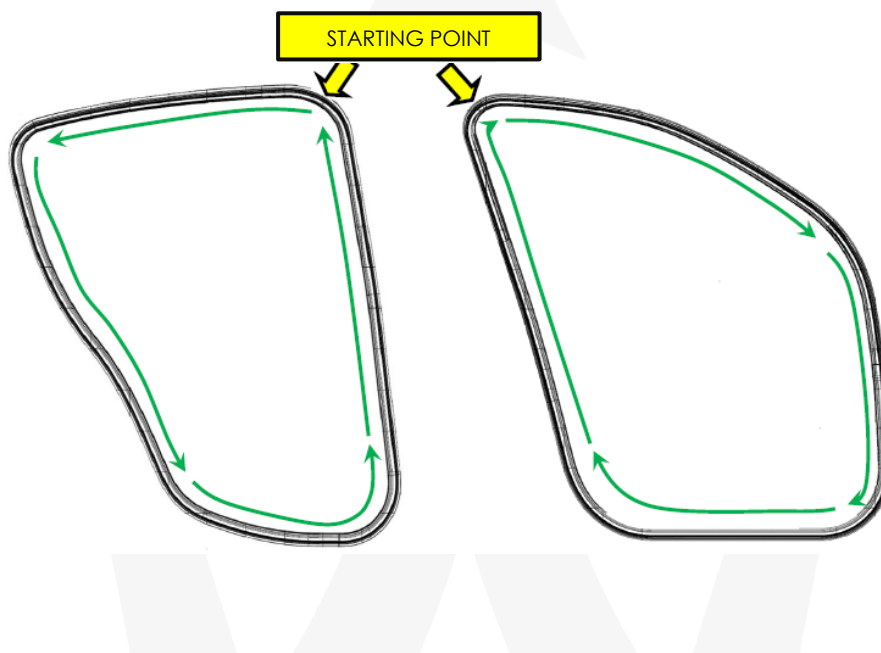
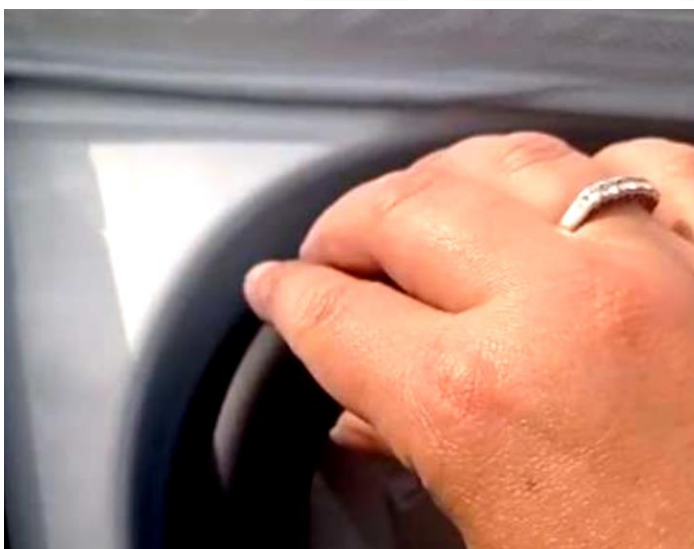
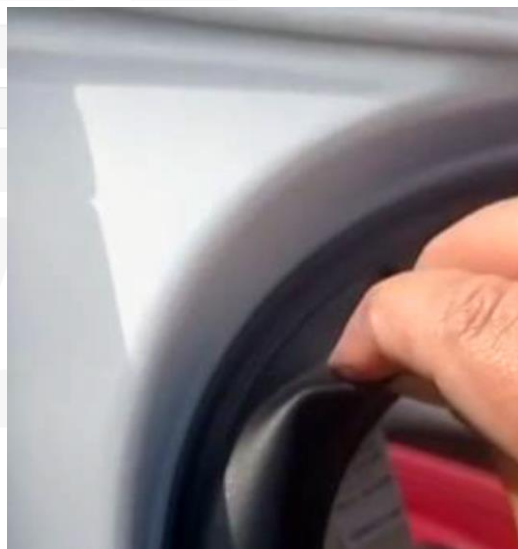
Open the vehicle door and, starting at the top of the "B" pillar, insert your fingers between the tube and the car's body. Gently separate the tubular component outward, as illustrated in the figure below.

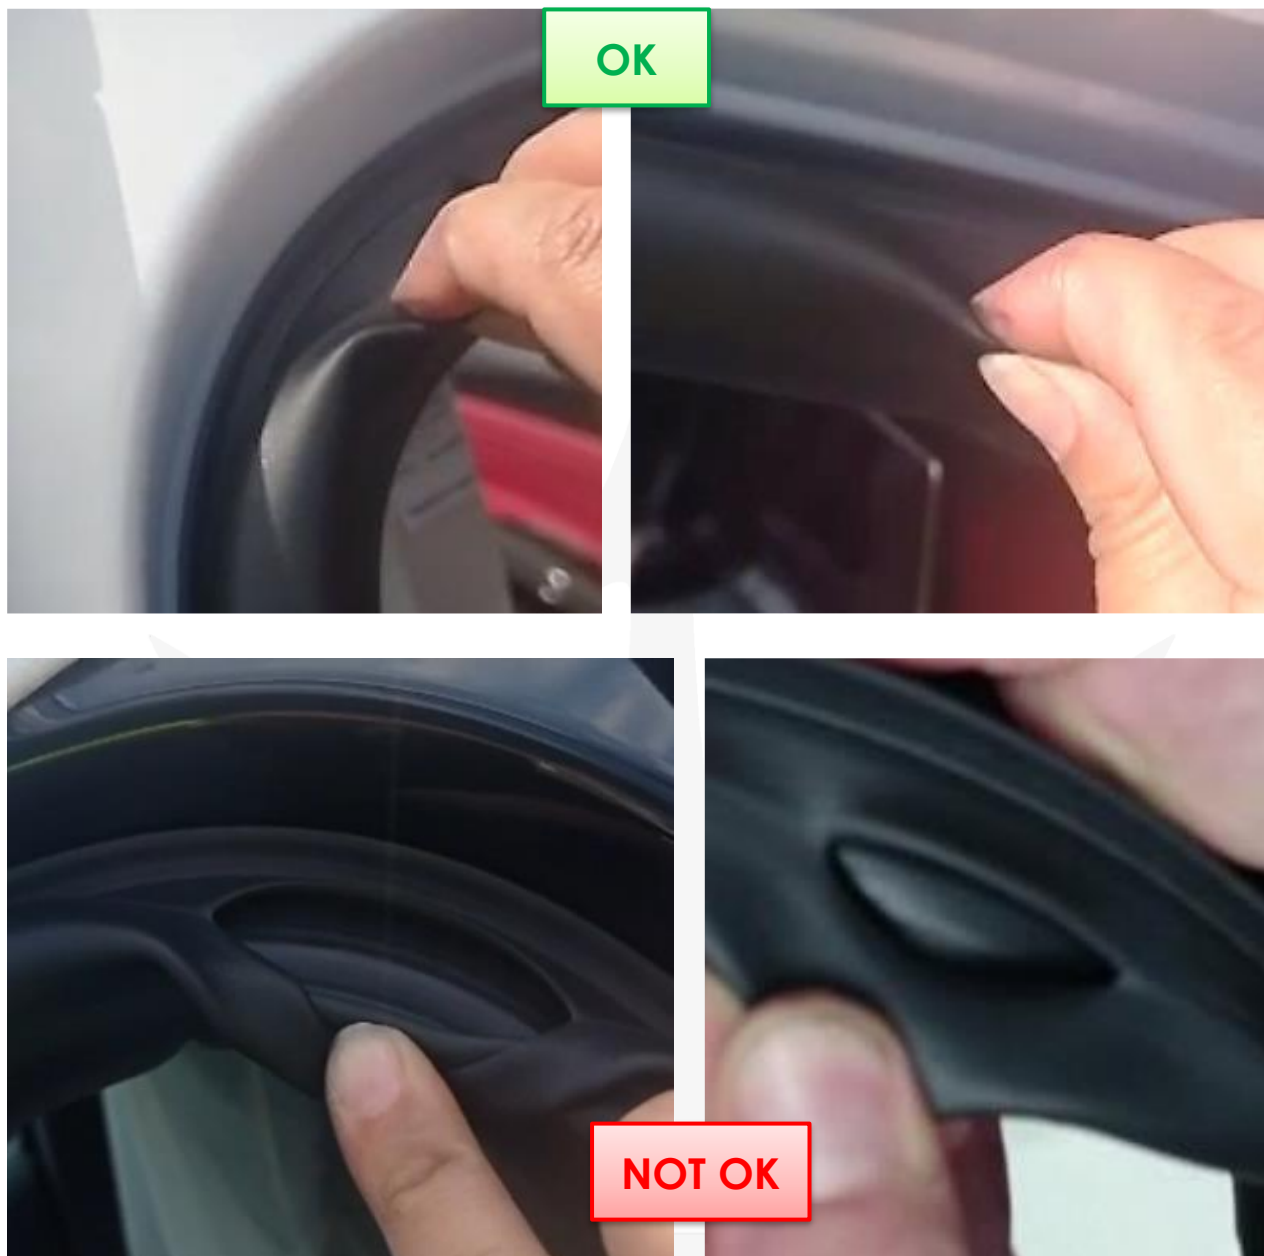
2. Run your fingers across the inside area of the tubing all along the vehicle door to check for discontinuities and/or holes in the seal.

- **OK ►** No defects or breakages are found; the gasket can be considered compliant. No further action needed.
- **NOT OK ►** Breakages and/or cuts found in the tubing. Gasket is **not compliant** and must be replaced.

4. Only replace the gasket that is **non-compliant**, following the instructions given in the workshop manual:
