Service

Section	Pre-Collision Safety	Market USA	Toyota Supports
---------	----------------------	------------	-----------------

YEAR(S)	MODEL(S)	ADDITIONAL INFORMATION	
2020 - 2023	4Runner		
2018 - 2022	Sequoia		
2018 - 2023	Tacoma		
2018 - 2021	Tundra

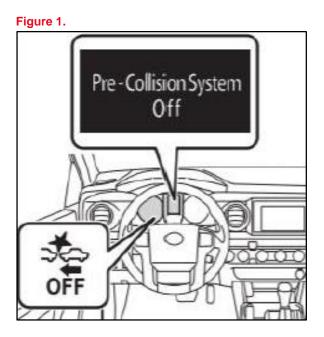
- 5. Reset the EFI-ECU using the following links to the reset tools.
 - Sequoia, 4Runner, Tundra: <u>Reset Tool</u>
 - Tacoma: <u>Reset Tool</u>
- 6. Confirm the PCS OFF light is Illuminated.
