Case Number: S2308000014

Release Date: February 2023

Symptom/Vehicle Issue: Anti-lock Brake System (ABS) Warning Lamp on

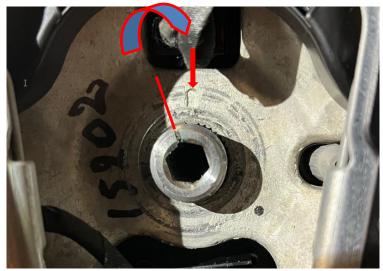
Owner Complaint/Technician Observation: Owner complains after a recent service repair for the steering column and an alignment the ABS warning lamp comes on at times. Technician observed Diagnostic Trouble Code (DTC) C0051-86 Steering Angle Sensor (SAS) – Signal Invalid, along with environmental data showing the steering angle sensor erratic reading of -500.8.

Example 21 MV: Improper centering after a steering wheel/column service.

Validate the vehicle is properly aligned. With the steering wheel centered, wheels straight, turn the steering wheel to the full right and then to full left from center counting the turns and monitoring the degree differences for side to side for possible offsets greater than 7.5 degrees. Correct any differences as needed to ensure proper calibrations Fig 1 and 2.

Reposition the misaligned parts, align the vehicle and use the scan tool to clear any offsets and calibrate as needed to complete. Select Electric Power Steering (EPS) - MISC Functions – **Steering Angle Calibration and Clear Steering Pull Compensation.**
