## Case Number: S2308000019

Release Date: February 2023

**Symptom/Vehicle Issue:** Auto High Beams Characteristics, Auto High Beams Not Turning on When Enabled

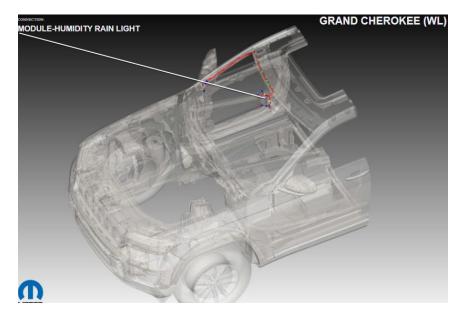
BCM Body Controller	/ehicle in s	hop	, amb	ient lig	ght	is low			
Flash DTCs Data Misc Functions	System Tests Actuators	Details C	Configuration						
▼ Type: All ▼ ● Record ▲ Units: Imperial ▼	🖬 Show All Data 🔟 Gra	ph Selection:	is j≣ Add To V	/ehicle Data 🛛 🕭 C	lear Sele	ctions 😻 0.1 s	Search		
Input Connectors									
Humidity Sensor Data									
NAME					MIN	VALUE	MAX	UNIT	TYPE
HRLS - Reported Ambient Light Level					(	320		LUX	LIN Data

BCM ody Controller		A bright	t incande	escent	lamp	directe	ed at the	ambient	light se	nsor
Flash DTCs	Data	Misc Functions	System Tests	Actuators	Details	Configurati	on			
<b>T</b> Type: All 👻 🗨	Record	Units: Imperial 👻	E Show All [	Data 🔟 Gra	ph Selecti	ons <b>i≡</b> Add	To Vehicle Dat	a 👌 Clear Selec	ctions 🛭 😎 0.1 s	Search
Input Connector	rs									
Humidity Senso	r Data									
NAME						MIN	VALUE	MAX	UNIT	TYPE
HRLS - Reporte	d Ambient L	ight Level				- (	5080		LUX	LIN Data

Use wiTECH to review the HRLSM light values under the BCM data folder looking for response change during increased and decreased lighting conditions (added lighting required).
