Revision (2) February 2023

Customer Satisfaction Notification Z60 Powertrain Control Module Software

2021-2022 (JT) Jeep® Gladiator

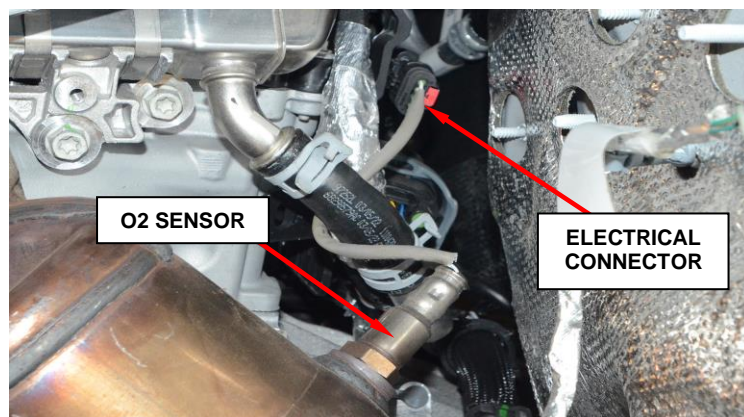
Figure 2 – O2 Sensor Electrical Connector

CAUTION: When disconnecting the oxygen sensor electrical connector, do not pull directly on the wire going into the sensor. The sensor wiring can be damaged resulting in sensor failure.

7. Remove the left/right downstream O2 sensor and **DISCARD**.
8. If necessary, clean the threads in the exhaust pipe using appropriate tap.
9. Hand start threading the **NEW** O2 sensor and tighten to 43N·m (32ft. lbs.).
10. Reconnect the O2 sensor electrical connector (Figure 2).
11. Align and install the splash shield to the wheel opening (Figure 1).
12. Install **NEW** rivets (Figure 1).
13. Install **NEW** push pin fasteners (Figure 1).
14. Install the screws and tighten to 5N·m (44In. lbs.) (Figure 1).
15. Install the wheel and tire assembly and tighten to 176N·m (130ft. lbs.).
16. Proceed to section **A. Reprogramming PCM Procedure.**
