REFERENCE:	TSB: 02-002-23 GROUP 02 - Front Suspension	Date:	February 1, 2023	REVISION:	-
VEHICLES AFFECTED:	2022 (WD) Dodge Durango This bulletin applies to vehicles built on or after August 01, 2022 (MDH 0801XX) and on or before September 12, 2022 (MDH 0912XX).	MARKET APPLICABILITY:			
		<input checked="" type="checkbox"/> NA		<input type="checkbox"/> CH	
		<input checked="" type="checkbox"/> EE		<input type="checkbox"/> IAP	
		<input checked="" type="checkbox"/> SA		<input checked="" type="checkbox"/> MEA	
CUSTOMER SYMPTOM:	<p>The technician of customer may notice one or more of the following:</p> <ul style="list-style-type: none"> • A loud noise from the front wheel area (worse on turns). • A humming or clunk noise, brake pulsation, or vibration in the steering wheel. 				
CAUSE:	Improperly torqued wheel bearing to knuckle joint bolts.

This bulletin involves tightening both front wheel bearing to knuckle joint bolts to spec.

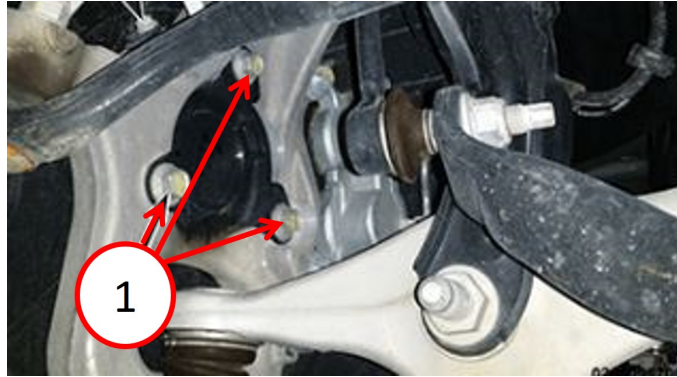
Fig. 1

Front Three Hub Bearing Mounting Bolts (2x4 Shown, 4x4 Similar)

1 - Hub Bearing Mounting Bolts

3. Tighten the front three hub bearing mounting bolts (Fig. 1) to 100 N·m (74 ft. lbs.). **Repeat this step for the other side of the vehicle.**
