Technical Service Bulletin (TSB)

Second Row Headrest Fold Flat Inoperative

REFERENCE:	TSB: 23-014-23 GROUP 23 - Body	Date:	February 1, 2023	REVISION:	-
VEHICLES AFFECTED:	2022 (WS) Grand Wagoneer/Wagoneer This bulletin applies to vehicles built on or after June 04, 2021 (MDH 0604XX) and on or before August 19, 2022 (MDH 0819XX).			MARKET APPLICABILITY:	
				<input checked="" type="checkbox"/> NA	<input type="checkbox"/> MEA
				<input type="checkbox"/> SA	<input type="checkbox"/> IAP
				<input type="checkbox"/> EE	<input type="checkbox"/> CH
CUSTOMER SYMPTOM:	<ul style="list-style-type: none"> • Second row seat does not fold flat. • Seat does not perform easy entry release to enter third row seating. • Seat headrest does not fold with electronic fold button. 				
CAUSE:	Either the: <ul style="list-style-type: none"> • Clips not correctly attached to frame by operator. • Cable adjusters not properly adjusted and/or locked. • Cables not routed correctly in frame.

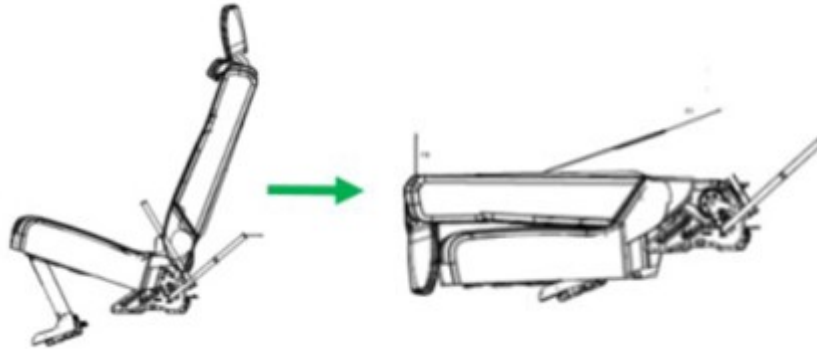
Fig. 1
Seat Locked Position

1. Move the seat from the upright to folded position, manually and by the electronic controls. Does the headrest go into the fold flat position (Fig. 1) ?

- YES>>> This bulletin has been completed, use inspect LOP (23-13-50-9A) if only performing this RSU to close the active RSU. If performing multiple RSUs for seat issues use related inspect LOP (23-13-50-51).
 - NO>>> Proceed to [Step 2](#).
2. Remove the seat. Refer to the detailed service procedures available in DealerCONNECT> Service Library under: Service Info> 23 - Body / Seats, Second Row /Seat, Second Row / Removal and Installation.
 3. Disassemble the seat back trim from the seat (Fig. 2) .
