Technical Service Bulletin (TSB)

Third Row Seat Won't Fold Due To Bent Lever

REFERENCE:	TSB : 23-015-23 GROUP 23 - Body	Date:	February 1, 2023	REVISION :	-
VEHICLES AFFECTED:	2022 (WS) Grand Wagoneer/Wagoneer This bulletin applies to vehicles built of 0604XX) and on or before September 2	It on or after June 04, 2021 (MDH		MARKET AF	PLICABILITY: MEA IAP CH
CUSTOMER SYMPTOM:	Customers may comment on the following:Third row manual seat will not lock in the recline position and will not fold flat with rear pull strap.				
CAUSE:	Lever is contacting with the cargo tub.

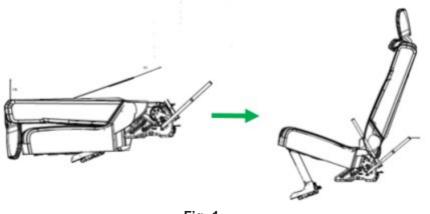
Fig. 1 Seat Locked Position

- 1. Move the third row seat from the folded position, to the upright position (Fig. 1). Does the seat lock in the first locking position?
 - YES>>> This bulletin has been completed, use inspect LOP (23-13-50-9D) if only performing this RSU to close the active RSU. If performing multiple RSUs for seat issues, use related inspect LOP (23-13-50-51).
 - NO>>> Proceed to Step 2.

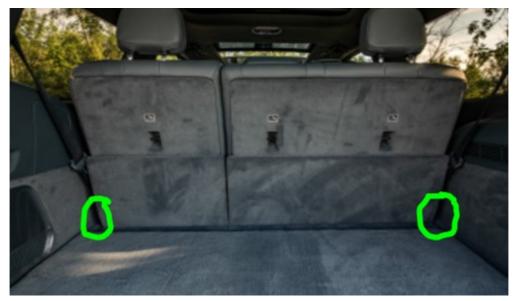
Fig. 2 Area To Inspect

2. Pull back the seat flipper panel and inspect both the left and right sides (Fig. 2), to see is if the metal strap bracket is contacting the cargo tub (Fig. 3).

- Using a suitable tool, slowly push the metal strap bracket outward, to create clearance away from the cargo tub (Fig. 3) do not bend the metal strap bracket more than 5 mm (0.19 in.). Repeat this step for the left, right or both seats.
- 2. Lift up one or both seats from folded flat position, to first locking upright seat position.
- 3. Did one or both seat stay in the upright locked position?
 - YES>>> This bulletin has been completed.
 - NO>>> Repeat Step 1 until one or both seats stay in the upright locked position.
- 4. Verify any other customer seat concerns with the latest available bulletins. Refer to all applicable published service bulletins for detailed repair procedures and labor times regarding updating the seat concerns.
