**Technical Service Bulletin (TSB)**  
**Third Row Headrest Fold Flat Inoperative**

<b>REFERENCE:</b>	<b>TSB:</b> 23-013-23 <b>GROUP</b> 23 - Body	<b>Date:</b>	February 1, 2023	<b>REVISION:</b>	-
<b>VEHICLES AFFECTED:</b>	<b>2022 (WS) Grand Wagoneer/Wagoneer</b> This bulletin applies to vehicles built on or after June 04, 2021 (MDH 0604XX) and on or before August 19, 2022 (MDH 0819XX) equipped with 3RD Row Seat-60/40 Power Recline (Sales Code CBB) or 3RD Row Seat-60/40 Manual Recline (Sales Code CFG).	<b>MARKET APPLICABILITY:</b>			
<b>CUSTOMER SYMPTOM:</b>	Third row headrest does not lock in the seating position.				
<b>CAUSE:</b>	<b>Either the:</b> <ul style="list-style-type: none"> <li>• Clips not correctly attached to frame by operator.</li> <li>• Cable adjusters not properly adjusted and/or locked.</li> <li>• Cables not routed correctly in frame.</li> </ul>

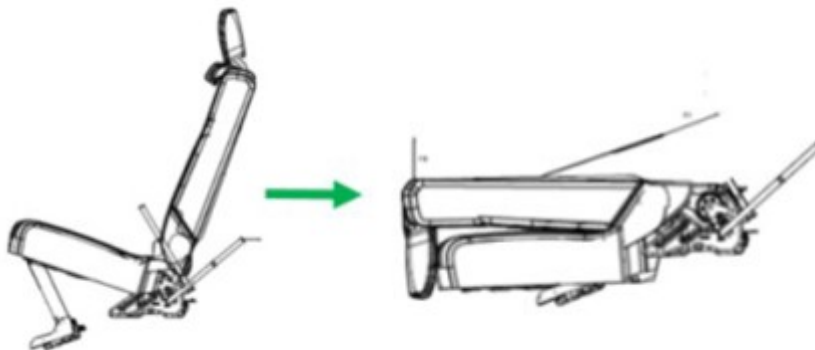
**Fig. 1**  
**Seat Locked Position**

1. Move the seat from the upright to folded position, manually and by the electronic controls. Does the headrest go into the fold flat position (Fig. 1) ?

- YES>>> This bulletin has been completed, use inspect LOP (23-20-63-93) if only performing this RSU to close the active RSU. If performing multiple RSUs for seat issues use related inspect LOP (23-13-50-51).
  - NO>>> Proceed to [Step 2](#).
2. Check that cable is attached to both Cam and Structure at the red circles (Fig. 2) .
