REFERENCE:	TSB: 23-025-23 GROUP 23 - Body	Date:	February 4, 2023	REVISION:	-
VEHICLES AFFECTED:	2022 (KL) Jeep Cherokee This bulletin applies to vehicles built on or after February 07, 2022 (MDH0207XX) and on or before August 25, 2022 (MDH0825XX)			MARKET APPLICABILITY:	
				<input checked="" type="checkbox"/> NA	<input type="checkbox"/> MEA
				<input type="checkbox"/> SA	<input checked="" type="checkbox"/> IAP
				<input type="checkbox"/> EE	<input type="checkbox"/> CH
CUSTOMER SYMPTOM:	Overhead Console is loose or falls down while driving and hangs by the wires.				
CAUSE:	Overhead console is not fully seated during assembly.

This bulletin involves inspecting and possibly re-securing the overhead console (overhead console)

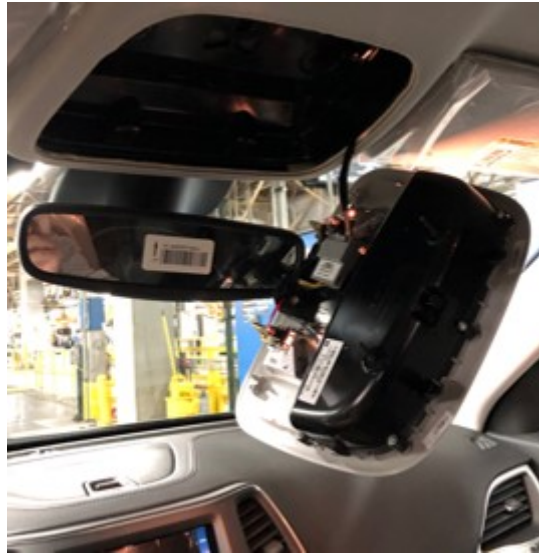
2. Is overhead console loose and/or does it fall out (Fig. 1) ?

Fig. 1
Overhead Console Fall Out

1. Re-secure the overhead console to the bracket above. Use higher than moderate pressure (up to 60 pounds force) to secure the two retainer clips into the overhead console mounting bracket.
2. Repeat pull test on sunglass holder to verify overhead console is secure.
