Rapid Service Update (RSU) Incorrect Serpentine Belt and Tensioner

REFERENCE:	TSB: 09-004-23 REV. A GROUP 09 - Engine	Date:	February 7, 2023	REVISION:	09-004-23
VEHICLES AFFECTED:	**2022** (RU) Chrysler Pacifica This bulletin applies to the following vehicles built on or after October 25, 2022 (MDH 1025XX) on or before November 04, 2022 (MDH 1104XX) equipped with a 3.6L V6 Hybrid Engine (Sales Code EH3).			MARKET APPLICABILITY: <input checked="" type="checkbox"/> NA <input type="checkbox"/> MEA <input type="checkbox"/> SA <input type="checkbox"/> IAP <input type="checkbox"/> EE <input type="checkbox"/> CH	
CUSTOMER SYMPTOM:	<ul style="list-style-type: none"> Premature engine belt wear or noise concerns when driving the vehicle. Belt could snap eventually resulting in water pump and alternator not being driven leading to overheating and dead battery. 				
CAUSE:	Incorrect belt tensioner

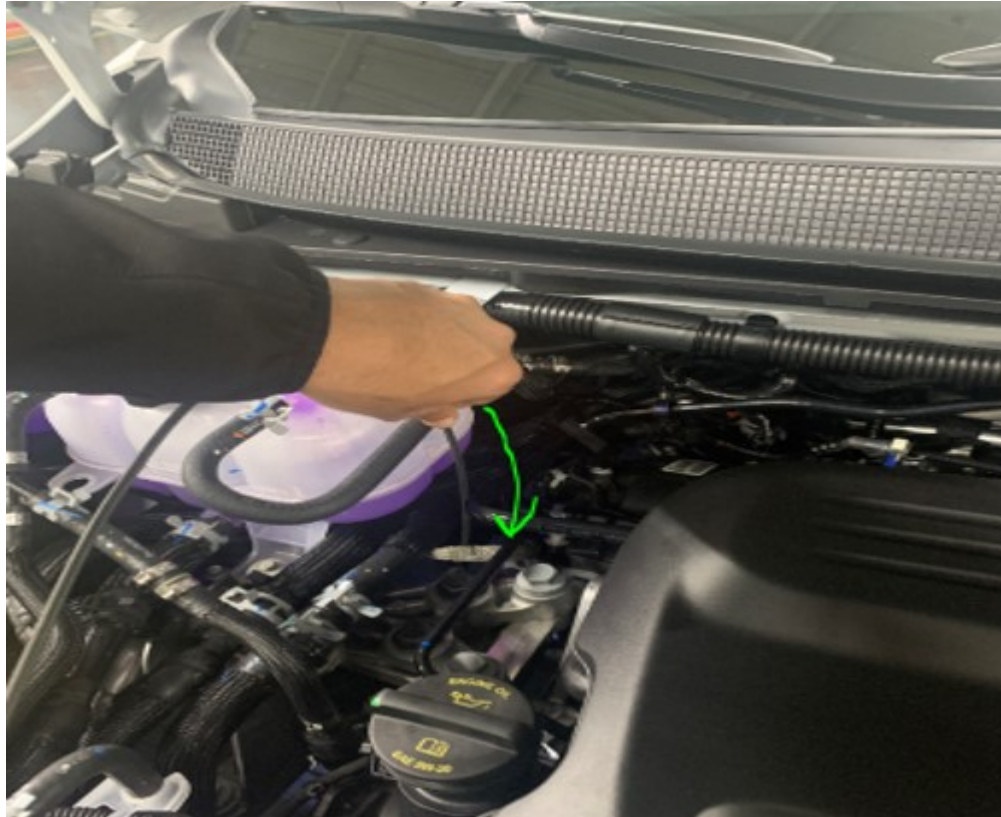
Fig. 1
BoreScope Inspection Location

- Using borescope, Insert the Tip of the borescope cable into the space as shown (Fig. 1) .

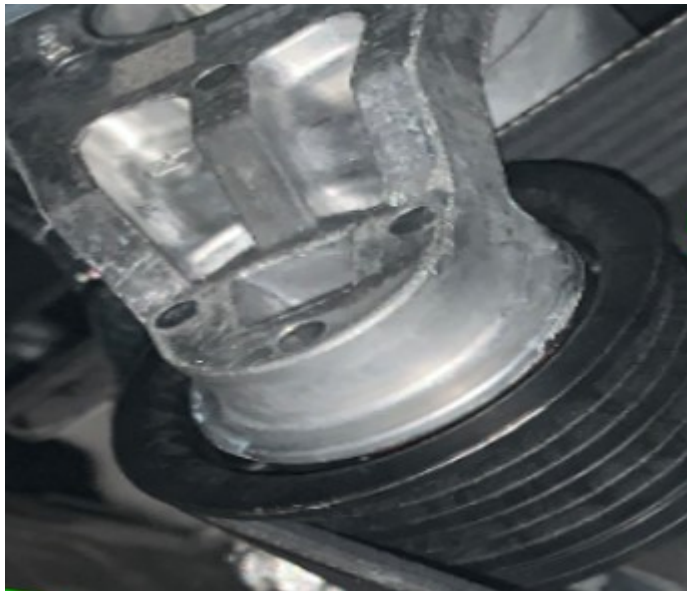
Fig. 2
(Correct) Grooved Belt and Tensioner

- When inspecting with borescope look for grooved tensioner pulley and grooved belt on the monitor (Fig. 2) .

NOTE: A flat/smooth tensioner pulley or with faded marks indicates the incorrect belt and tensioner are installed and must be replaced.

3. Does the tensioner pulley and belt have grooves? (Fig. 2)

- YES>>> This bulletin has been completed, use inspect LOP (07-20-18-97) to close the active RSU.
- NO>>> Proceed to [Step 1](#) of the Repair Procedure.

1. Remove the serpentine belt and discard. Refer to the detailed service procedures available in DealerCONNECT/Service Library under: Service Info>07 - Cooling / Accessory Drive / Belt, Serpentine / Removal.
2. Replace the tensioner. Refer to the detailed service procedures available in DealerCONNECT/Service Library under: Service Info>07 - Cooling / Accessory Drive / Tensioner, Belt / Removal and Installation.
3. Install the new serpentine belt. Refer to the detailed service procedures available in DealerCONNECT/Service Library under: Service Info>07 - Cooling / Accessory Drive / Belt, Serpentine / Installation.
4. Clear any DTCs that may have been set.
