<b>REFERENCE:</b>	<b>TSB:</b> 08-053-23 <b>GROUP</b> 08 - Electrical	<b>Date:</b>	February 17, 2023	<b>REVISION:</b>	—						
<b>VEHICLES AFFECTED:</b>	<p><b>2022 (RU) Chrysler Pacifica</b>  <b>The RSU portion of this bulletin only applies to vehicles built on or after August 26, 2022 (MDH 0826XX) and on or before September 29, 2022 (MDH 0929XX) equipped with:</b></p> <ul style="list-style-type: none"> <li>• Uconnect 5 Nav w/10.1" Display (USA) (Sales Code UBN).</li> <li>• Uconnect 5 Nav w/10.1" Display (CAN) (Sales Code UEN).</li> <li>• Uconnect 5 w/10.1" Display (USA) (Sales Code UBG).</li> <li>• Uconnect 5 w/10.1" Display (CAN) (Sales Code UEG).</li> <li>• Uconnect 5 w/10.1" Display (MEX) (Sales Code UFG).</li> <li>• Uconnect 5 Nav w/10.1" Display (MEX) (Sales Code UFN).</li> </ul>			<p><b>MARKET APPLICABILITY:</b></p>

<b>CAUSE:</b>	Radio software
---------------	----------------

This bulletin involves inspecting the software level and updating the software to S26.17.

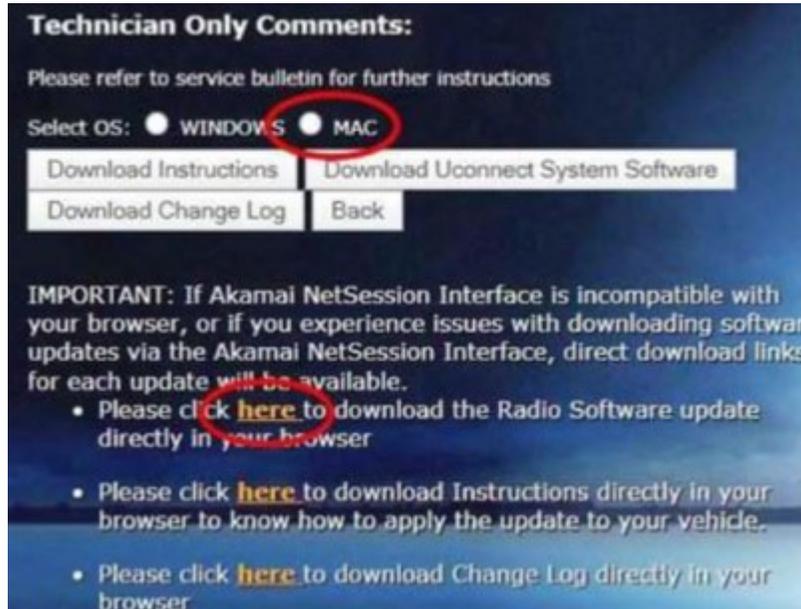
Fig. 1

- Download the software update file to your local PC's desktop. Make sure to select the "MAC" radial button for all downloads (Fig. 1) .

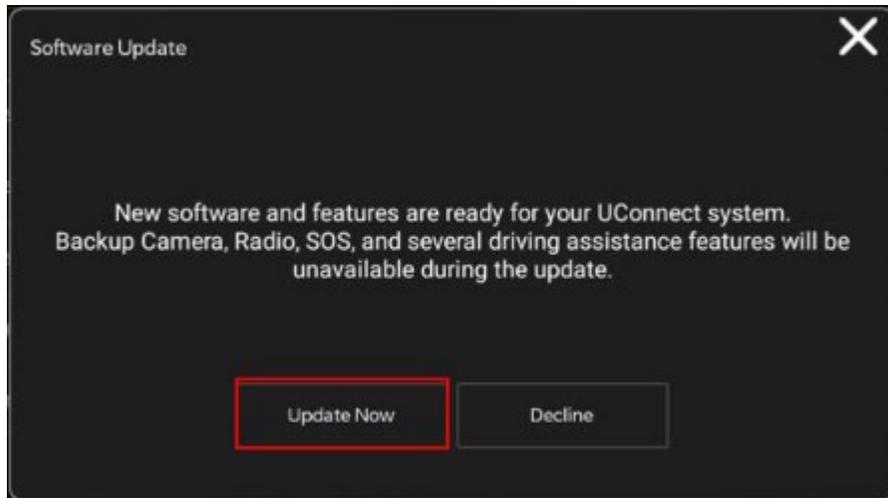
Fig. 2  
Software Update Is Available

12. Once the system has verified there is an available update, press the “Update Now” button. Make sure the vehicle is in park. **Do NOT turn the ignition off until the two minute timer has expired. The ignition doesn’t have to be turned off to update the radio’s software (Fig. 2) .**

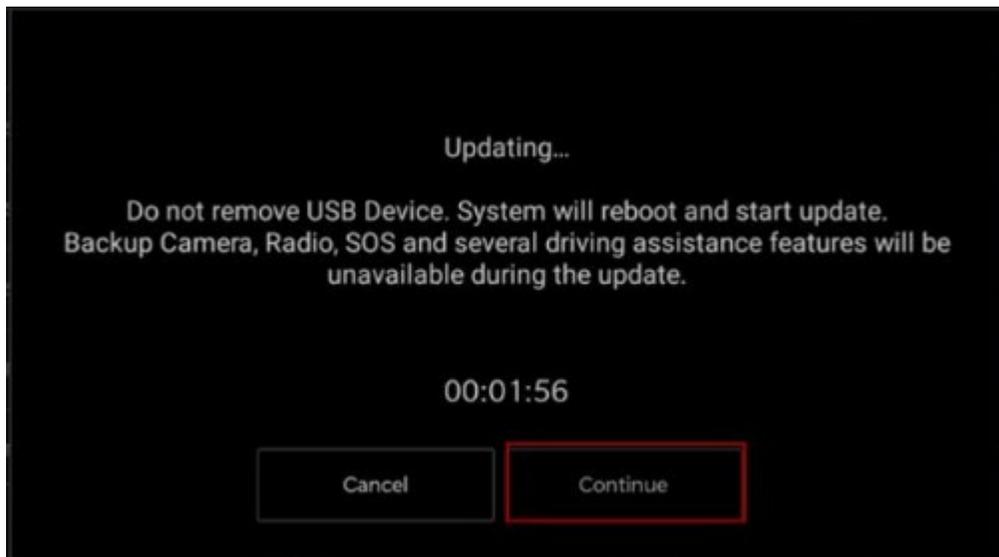
Fig. 3  
Continue Display Screen

13. Press the “Continue” on the display screen (Fig. 3) .

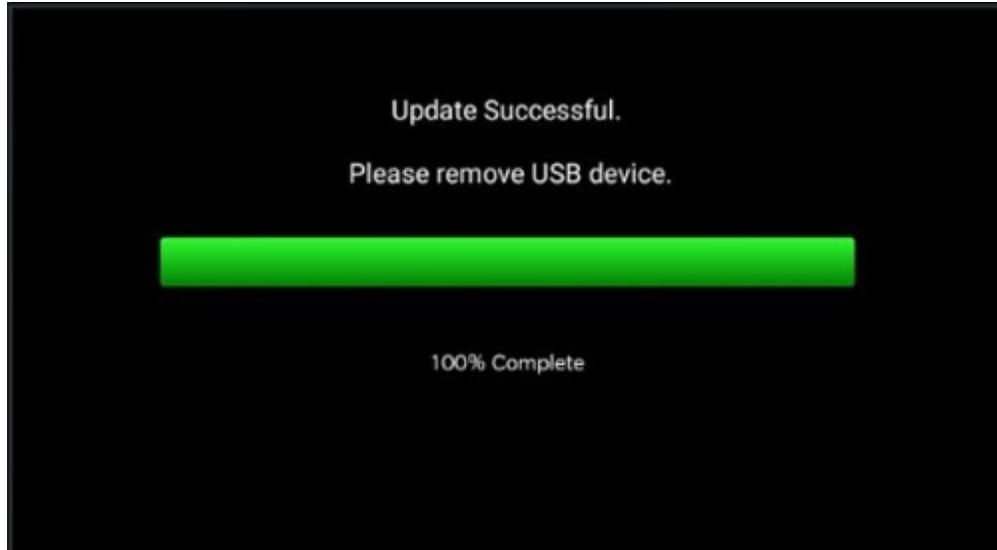
**Fig. 4**  
**Software Update Completed**

14. The radio will reboot and the update will begin. The update should only take 30 minutes (Fig. 4) .

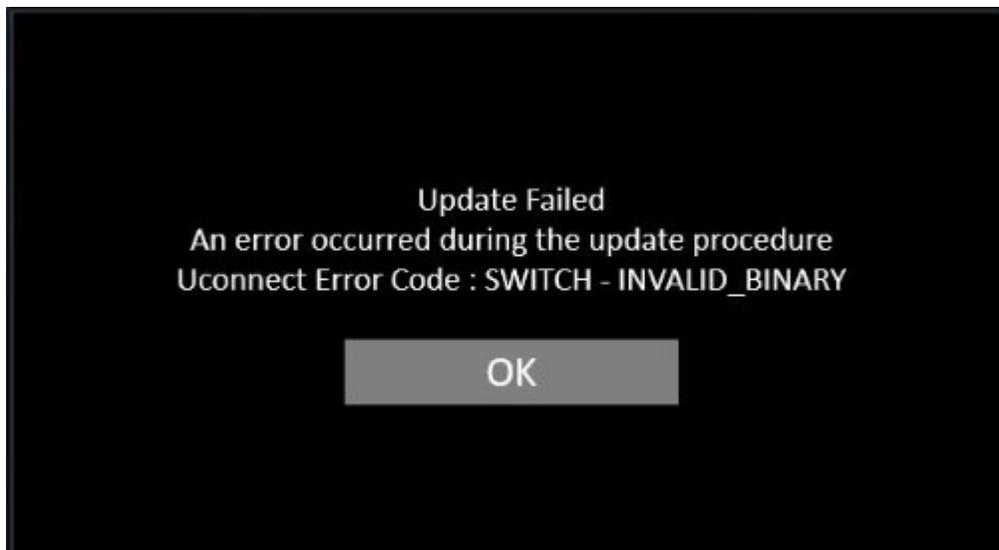
**Fig. 5**  
**Error Message**

15. **Do Not** turn off the ignition at this point. The update is still in process, wait until the radio restarts and the home screen is displayed. This should take around five minutes
16. Sometimes the radio will display an error pop up " Invalid\_Binary\_Switch " after successful radio update. Please ignore this error message and press "OK" to continue (Fig. 5) .

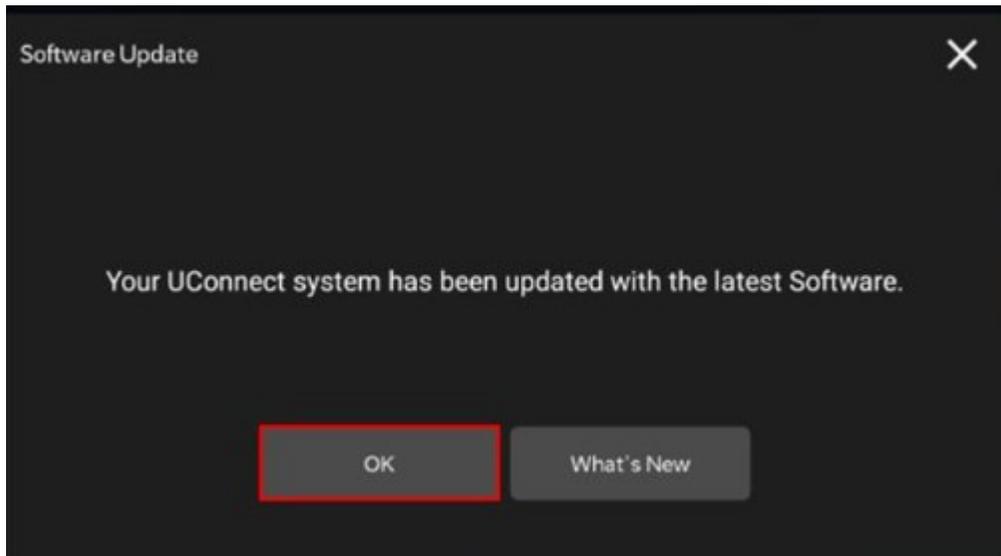
**Fig. 6**  
**Radio Software Has Been Updated**

17. Press “OK” to continue (Fig. 6) .
