This bulletin involves water testing the rear tail lamps and replacing if needed.

Rear lamp assembly

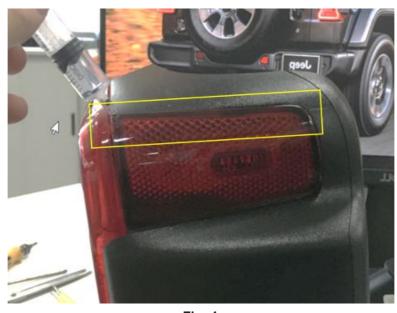
Fig. 1
Location of Water Intrusion Area

1. Apply water at the corner of the upper side marker. Make sure applied water covers all of top lens corner and top side of lens (Fig. 1) .

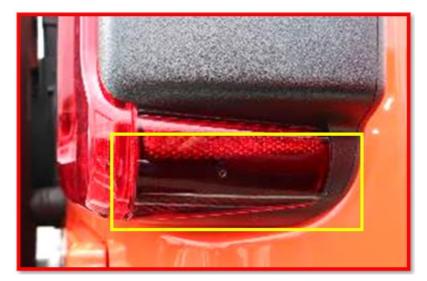
NOTE: Water intrusion into the tail lamp side marker area will appear as a dark spot (Fig. 2) and side marker is clear without water intrusion (Fig. 3).

Fig. 2
Water Intrusion Side Marker

- YES>>> Replace the tail lamp with water intrusion. Proceed to Step 3.
- NO>>> This bulletin has been completed, use inspect LOP (08-50-85-9D) to close the active RSU.
- 3. Only replace the tail lamp with water intrusion. Refer to the detailed service procedures available in DealerCONNECT> Service Library under: Service Info> 08 Electrical / 8L Lamps and Lighting / Lamps/Lighting Exterior / Lamp, Tail Stop Turn / Removal and Installation.

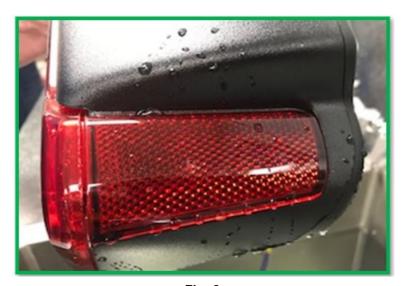
Fig. 3
No Water in Side Marker
