<b>REFERENCE:</b>	<b>TSB:</b> 08-051-23 REV. A <b>GROUP</b> 08 - Electrical	<b>Date:</b>	February 18, 2023	<b>REVISION:</b>	08-051-23
<b>VEHICLES AFFECTED:</b>	<b>2023 (DT) RAM 1500 Pickup</b> This bulletin applies to vehicles built on or after <b>October 27, 2022 (MDH 1027XX)</b> and built on or before <b>December 08, 2022 (MDH 1208XX)</b> and equipped with one of the following radios: <ul style="list-style-type: none"> <li>• Uconnect 5 NAV W 8.4" Display (Sales Codes UBL or UEL).</li> <li>• Uconnect 5 NAV W 12" Display (Sales Codes UBQ, UEQ, UFQ or UPQ).</li> </ul>			<b>MARKET APPLICABILITY:</b>	
				<input checked="" type="checkbox"/> NA	<input checked="" type="checkbox"/> MEA
				<input checked="" type="checkbox"/> SA	<input checked="" type="checkbox"/> IAP
				<input checked="" type="checkbox"/> EE	<input type="checkbox"/> CH
<b>CUSTOMER SYMPTOM:</b>	<b>The customer may describe the following:</b> <ul style="list-style-type: none"> <li>• Menu button on steering wheel control will activate Voice Recognition on the Head Unit (12" Cluster Vehicles Only).</li> <li>• Suspension menu tile will be missing from vehicle settings list.</li> <li>• Power side-step setting is missing from

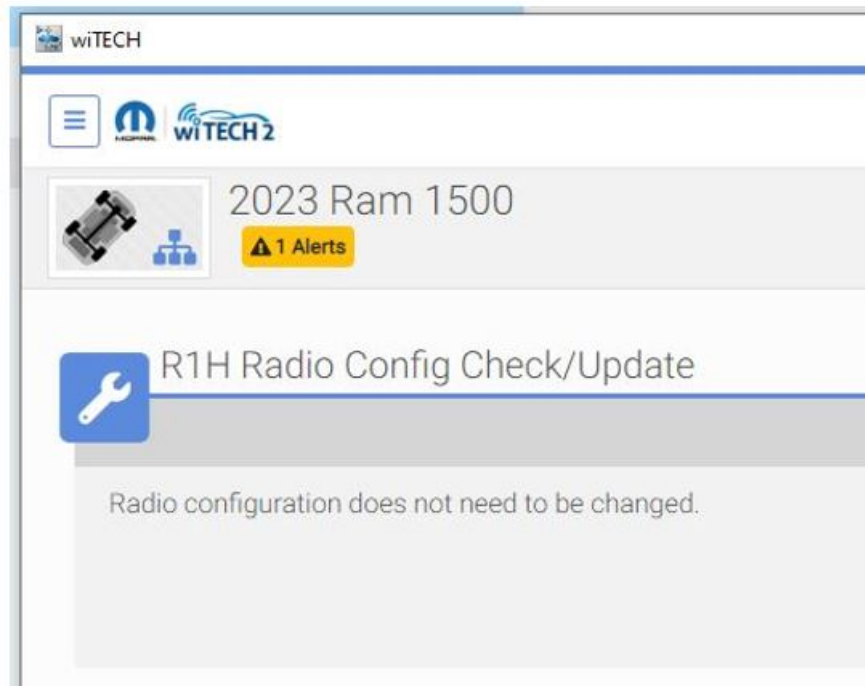
**NOTE:** The scan tool will only display the “R1H Radio Config Check/Update” routine, if the vehicle needs it (Fig. 1) .

**Fig. 1**  
**Audio Configuration is NOT needed**

- Using wiTECH, select “R1H Radio Config Check/Update”, located in “Guided Diagnostics”. Follow screen prompts to complete this routine.
