REFERENCE:	TSB: 23-028-23 GROUP 23 - Body	Date:	February 21, 2023	REVISION:	-
VEHICLES AFFECTED:	2022 (WS) Grand Wagoneer/Wagoneer This bulletin applies to vehicles built on or before February 28, 2022 (MDH 0228XX) equipped with a Rear Back Up Camera Washer (Sales Code JHE), Surround View Camera System (Sales Code XAK), Night Vision/Ped-Animal Detection (Sales Code XNT) or a Rear View Autodim Digital Display Mirror (Sales Code GRG).	MARKET APPLICABILITY: <input checked="" type="checkbox"/> NA <input type="checkbox"/> CH <input type="checkbox"/> EE <input type="checkbox"/> IAP <input type="checkbox"/> SA <input type="checkbox"/> MEA			
CUSTOMER SYMPTOM:	Customers may comment on one or more of the following: <ul style="list-style-type: none"> • Camera washers are not spraying fluid (front and/or rear). • A washer fluid leak behind the front fascia/grille, above the rear of the headliner, or liftgate.

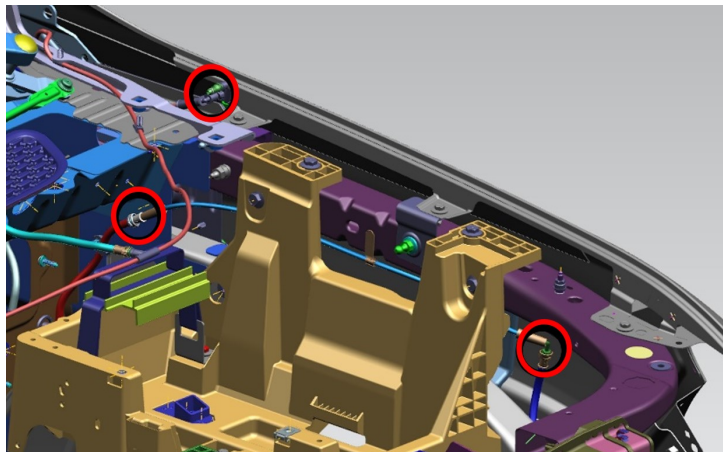
Fig. 1

Driver Side Under Hood - Three Connections

1. **For Under Hood Leaks (Fig. 1)** . Open the hood.
2. Verify all three connections (Fig. 1) with a push-pull-push test and confirm all three connections are tight.

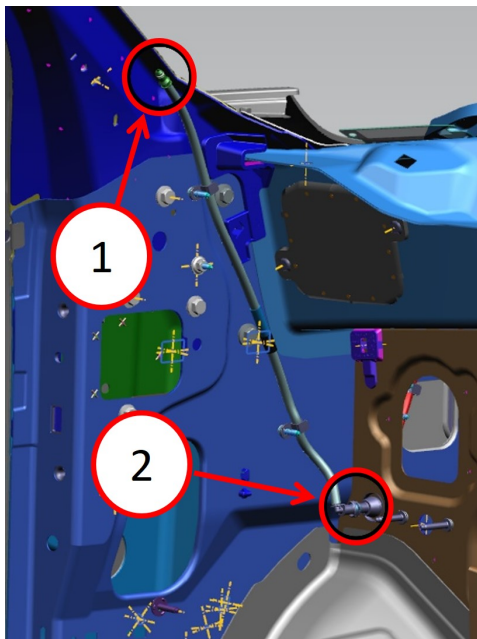
Fig. 2
Inside Cabin, Driver Side - Two Connections

- 1 - A-Pillar Connection
- 2 - Left Front Carpet Connection (See Note Below)

NOTE: If washer tube leak is determined to be at connection two (Left Front Carpet Connection) as shown in (Fig. 2) , contact STAR Center for repair instructions.

4. **Inside Cabin, Driver Side Leaks (Fig. 2)** . Remove the A-Pillar trim. Refer to the detailed service procedures available in DealerCONNECT> Service Library under: Service Info>23 - Body / Interior / Panel, A-Pillar Trim / Removal.
5. Verify connection (Fig. 2) with a push-pull-push test and confirm connection is tight.

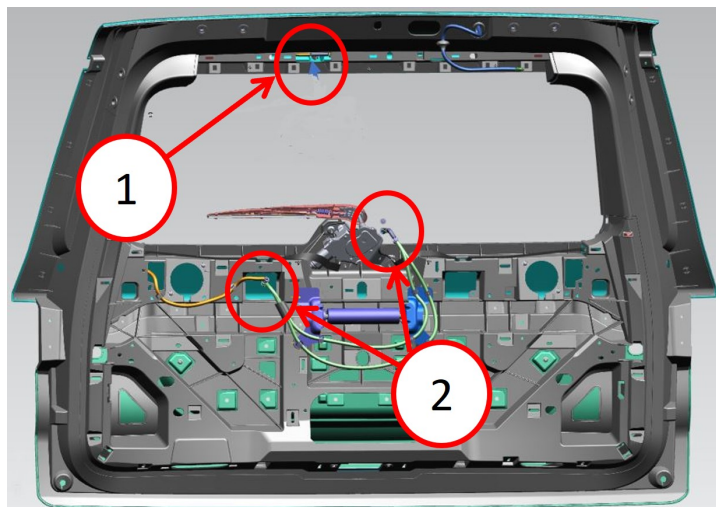
Fig. 6

Liftgate Location Connections

- 1 - Connection Behind Center High Mounted Stop Lamp (Also See Close-Up Fig. 7)
- 2 - Rear Window Wiper (Also See Close-Up Fig. 8)

15. **For Liftgate Leaks (Fig. 6)** . Remove the center high mounted stop lamp. Refer to the detailed service procedures available in DealerCONNECT> Service Library under: Service Info>08 - Electrical / 8L - Lamps and Lighting / Lamps/Lighting - Exterior / Lamp, Center High Mounted Stop / Removal.
16. Remove the lower liftgate trim panel. Refer to the detailed service procedures available in DealerCONNECT> Service Library under: Service Info>23 - Body / Decklid/Hatch/Liftgate/Tailgate/Swing Gate / Panel, Trim, Liftgate / Removal.
17. Verify all connections (Fig. 6) with a push-pull-push test and confirm connection is tight. See figures (Fig. 7) and (Fig. 8) for close-ups of two of these locations.

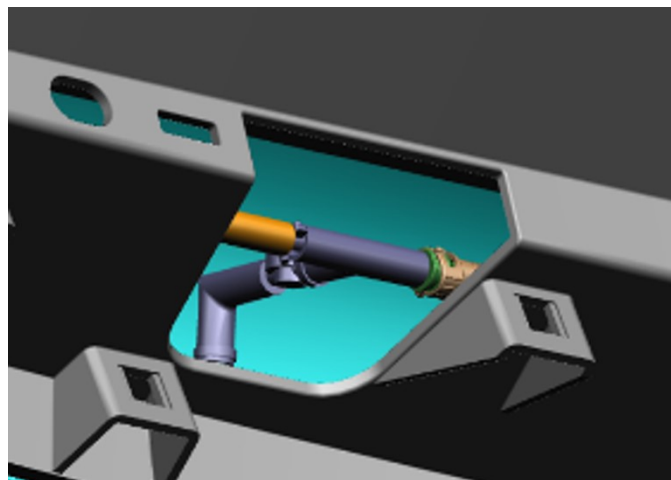
Fig. 7

Close-Up Connections Behind Center High Mounted Stop Lamp
