REFERENCE:	TSB: 23-026-23 REV. A GROUP 23 - Body	Date:	February 22, 2023	REVISION:	23-026-23
VEHICLES AFFECTED:	2023 (WL) Grand Cherokee This bulletin applies to vehicle built on or after **December 8, 2022 (MDH 1208XX) and on and before December 11, 2022 (MDH 1211XX)** .		MARKET APPLICABILITY: <input checked="" type="checkbox"/> NA <input checked="" type="checkbox"/> MEA <input type="checkbox"/> SA <input type="checkbox"/> IAP <input type="checkbox"/> EE <input type="checkbox"/> CH		
CUSTOMER SYMPTOM:	Either or both front door inside trim panels are loose or have a gap at the doors.				
CAUSE:	<ul style="list-style-type: none"> The 10 Push fasteners that secure the inside door trim panel to the door have not been fully seated into the door during assembly.

This bulletin involves re-securing the front door trim panels to the doors.

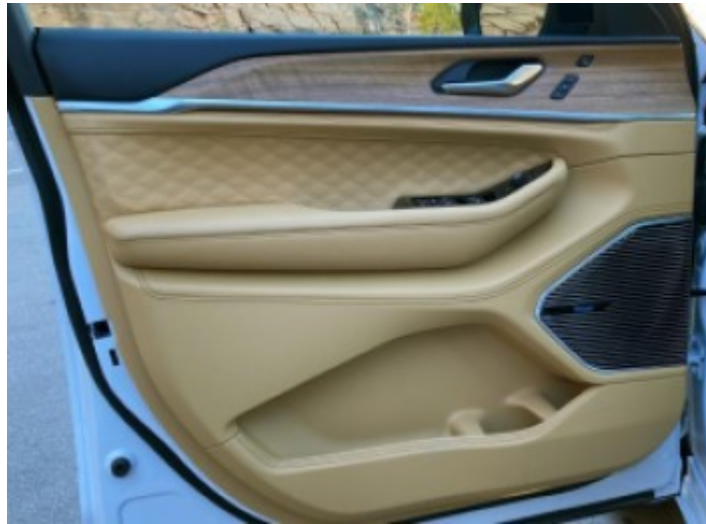
Fig. 1
Front Door Trim Panel

1. Door inside trim panels are not secured to the doors (Fig. 1) .
