MDI, (ABS) Software Update and Brake Inspection

Mack

Years	Models
2019-2021	AN

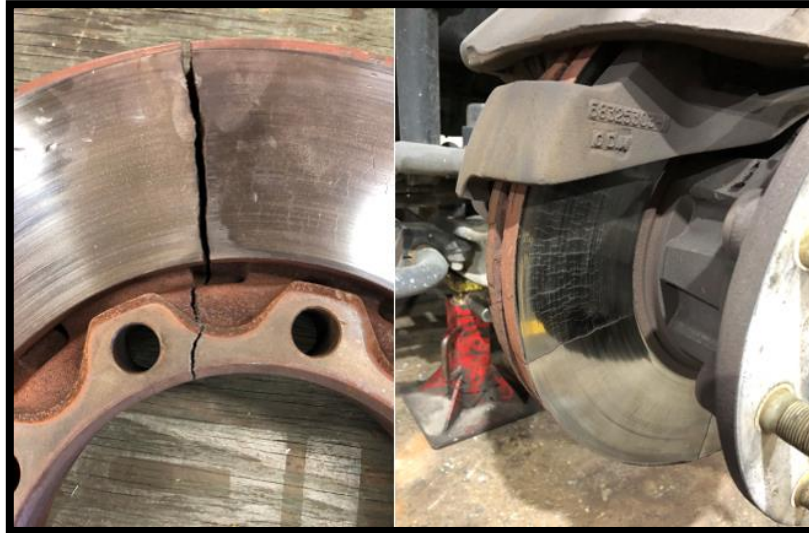
1. Secure truck for service.
2. Place the gear lever in neutral.
3. Install wheel chocks.
4. Perform a visual inspection of the driver and passenger side, steer axle's brake rotors. Check for excessive heat damage resulting in cracked or broken rotors, see examples below.

Note!
Heat checking marks are normal and do not require replacement.

(Example of failed rotors)

- A. If a damaged rotor is found during the inspection, reach out to Michael Moriarty for labor and part replacement approval at michael.moriarty@volvo.com or (336) 338-6947. Once replacement has been approved continue to **step 5**.
- B. If no damage is found during the inspection, proceed to the Programing Procedure below.

5. Replace steer axle rotors, pads, caliper mounting bolts, and seals with new ones, following the manufacture's repair instructions.
