Technical Service Bulletin

19 Red Coolant warning lamp comes on OR Coolant Leak at Turbocharger

19 23 47 2072473/1 December 21, 2023.

Model(s)	Year	VIN Range	Vehicle-Specific Equipment
A8	2019 – 2021	All	4.0 L engine
S8	2020 – 2023

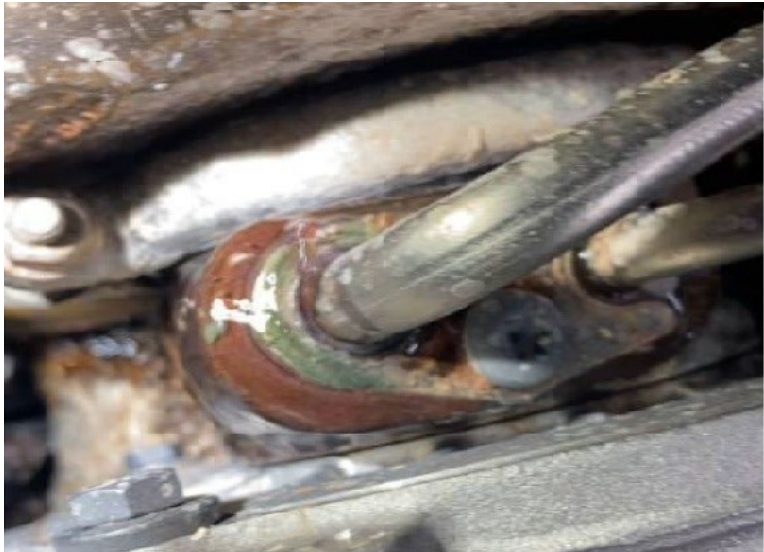
A coolant leak is identified at the return lines to the turbocharger (Figure 1).

Figure 1: Coolant leak at the return lines to the turbocharger.

In some model years, After-Run Coolant Pump (V51) start with a slight delay. This can lead to unintended additional heat at O-rings at the return connected to the turbochargers.

- Replace the O-rings at the coolant return lines at the Turbocharger (refer to Figures 2 and 3 or SSP **920493**).
- **Please remove and install the coolant return line according to workshop manual (ELSA) and also replace O-rings on the coolant at the crankcase side (Figure 3).**

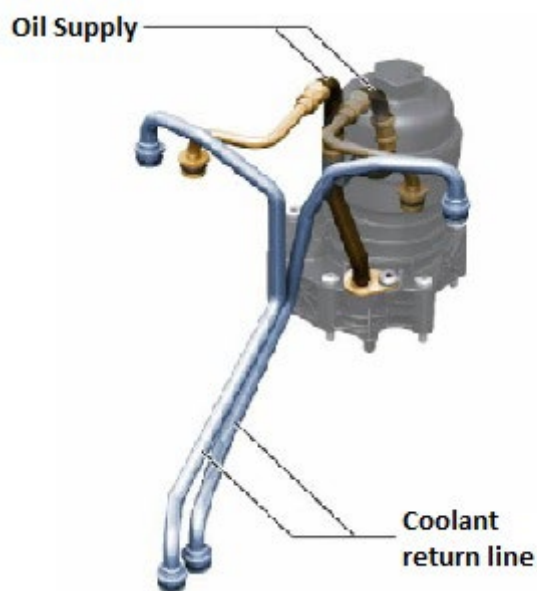
Figure 2: Coolant return lines are marked.

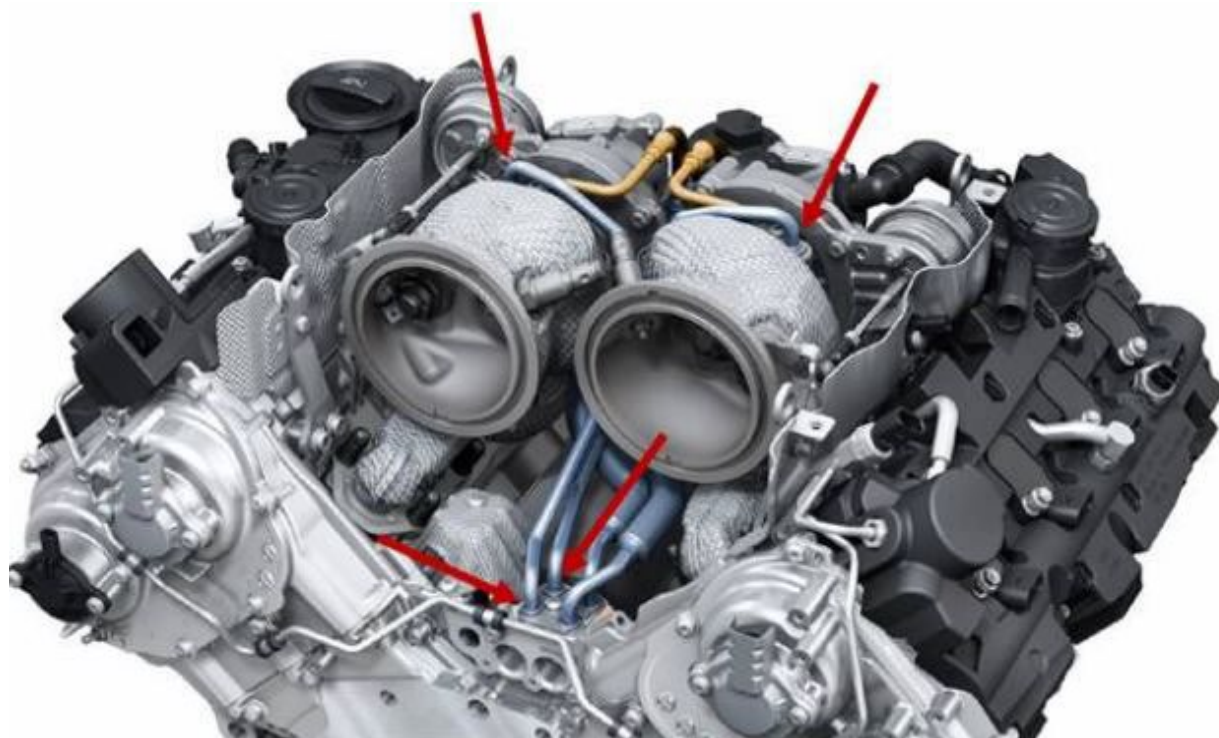
Figure 3: Location of the O-rings.
