Technical Service Bulletin

90 Audi virtual cockpit: speedometer needle flickers while driving.

90 23 64 2072514/1 December 21, 2023.

Model(s)	Year	VIN Range	Vehicle-Specific Equipment
A6, A7, A8, Q7, and Q8	2019	All	Virtual Cockpit

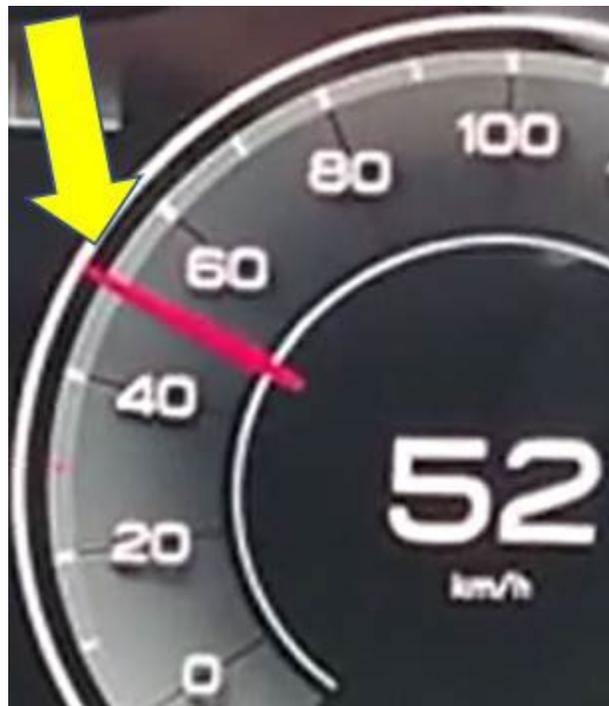
Customer states: The red needle of the speedometer in the Audi virtual cockpit flickers while driving (yellow arrow Figure 1).

Workshop findings: The flickering can be seen in both the standard view (large speedometer) and the extended view (small speedometer).

- Flickering does not occur when the vehicle is stationary.
- The correct speed is indicated.
- The red needle in the RPM gauge does not flicker.

Figure 1: Speedometer needle in instrument cluster flickers

Software issue in Audi virtual cockpit.

1. Follow all instructions in TSB 2011732: *00 Software Version Management (SVM), operating instructions.*
2. Update the Audi virtual cockpit -J285- (diagnostic address 0017) using the SD card and SVM code as listed in the table below.
