**Surround Camera Intermittent Operation**

**Vehicles Affected**

Models	Model Year	Model Type	VIN Range	Vehicle-Specific Equipment
Cayenne	As of 2019 up to 2023	9YA, 9YB	N/A	KA6

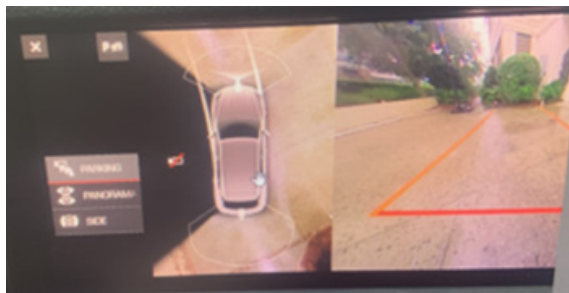
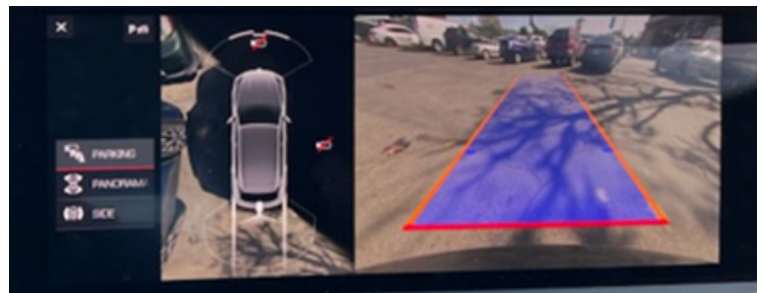
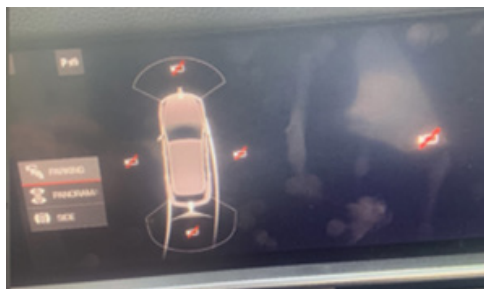
Customer complains of intermittent operation for one or multiple surround view cameras while appearing blank with a crossed-out camera icon for each failed camera.
