992 2WD – DME Fault P310B00 – ‘Fuel Low Pressure – Implausible’

Vehicles Affected

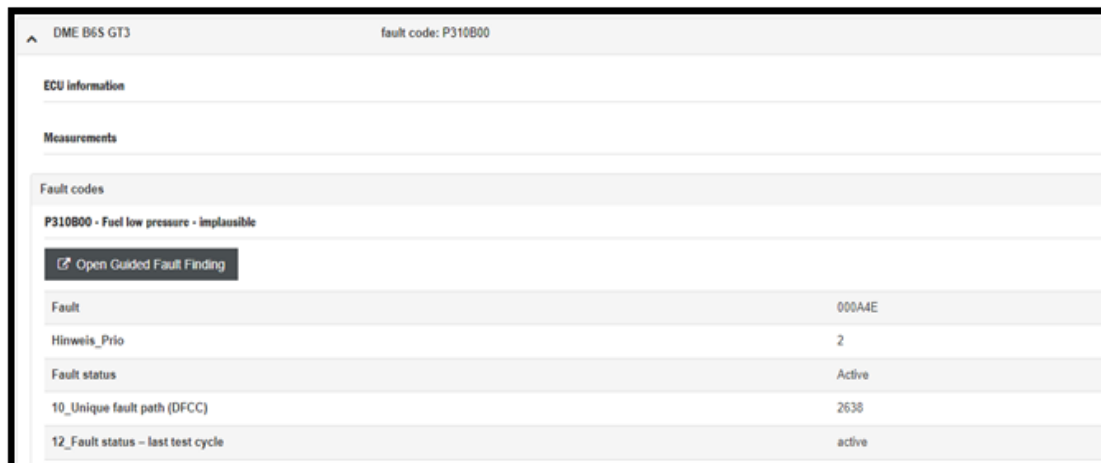
Figure 1

The diagnostic responsible for this fault monitors supply deviation within a finite time between the demanded or target low-pressure requested of the low-pressure fuel pump and that of the actual supplied quantity to meet the request, as correlated to pressure. In some instances, manufacturing tolerances for the low-pressure pump result in the actual supplied fuel quantity exceeding the DME's requested quantity, in other words, the pump's operation is 'too effective.' By consulting the Vehicle Analysis Log (VAL) containing the fault it is possible to see if the supplied fuel quantity exceeded the requested quantity in the low-pressure system to cause the fault.

In the example provided below of Figure 2, with imperial units provided, it is apparent the excess low-pressure fuel supply caused the fault. Specifically, the value “B220_Fuel pressure actual value” of 10653.7 lbf/ft² exceeds “B221_Fuel low pressure setpoint” of 10442.7 lbf/ft². This deviation occurred despite the DME regulating the demand downwards (-) by 1948.6 lbf/ft² or 14.99% to compensate for the excess supply, but the regulation could not compensate enough to prevent the fault.

If the fault data is consistent with the condition exemplified in Figure 1, please replace the fuel pump, **NOT** the fuel pressure sensor.
