## Subarunet Announcement

**Date: December 14, 2023**

### **UPDATE** Safety Recall/STOP SALE: WRP-23 Driveshaft Failure

#### **Service, Parts, and Claim Instructions**

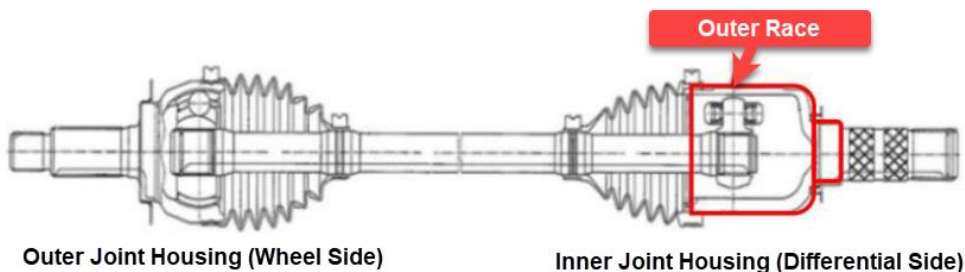
The vehicles included in this recall may be equipped with a front drive shaft assembly with an outer race (shown below) that could crack, due to improper cooling during the manufacturing process.

For stop sale and SSLP vehicles only, Subaru retailers should inspect the front drive shaft lot numbers. If the affected lot number is found, the vehicle is to remain on HOLD under this stop sale until recall remedy parts are available. A future announcement will be made when parts are available.
